**ST JAME'S CHURCH
TEIGNMOUTH, DEVON**

QUINQUENNIAL INSPECTION REPORT

Inspector: Mr Grant Elliott, RIBA, CA

Date of Inspection: 9th November 2022

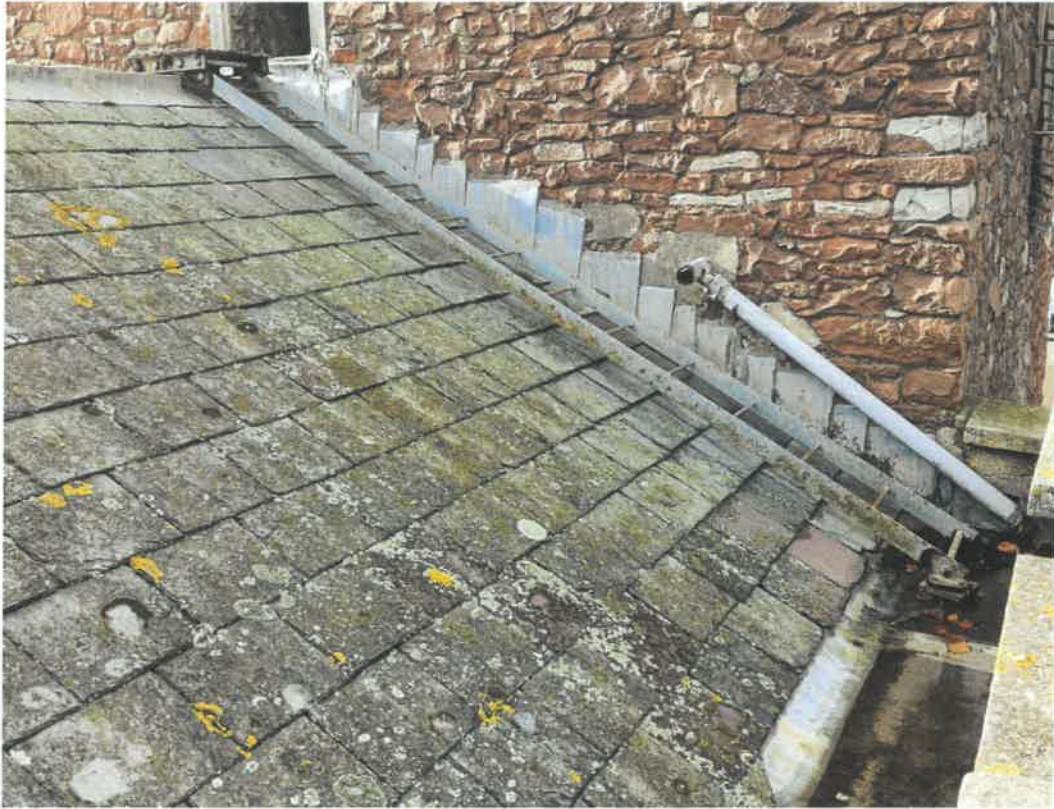
As noted in the previous report, the back gutters are covered with lead sheet and the bays are far too long, causing numerous splits to develop. These have been repaired temporarily with flashband and ongoing repairs will be needed regularly until these gutters are renewed properly with new lead in smaller bays. **C**

06 Overlong Valley Gutter with Flashband Repairs

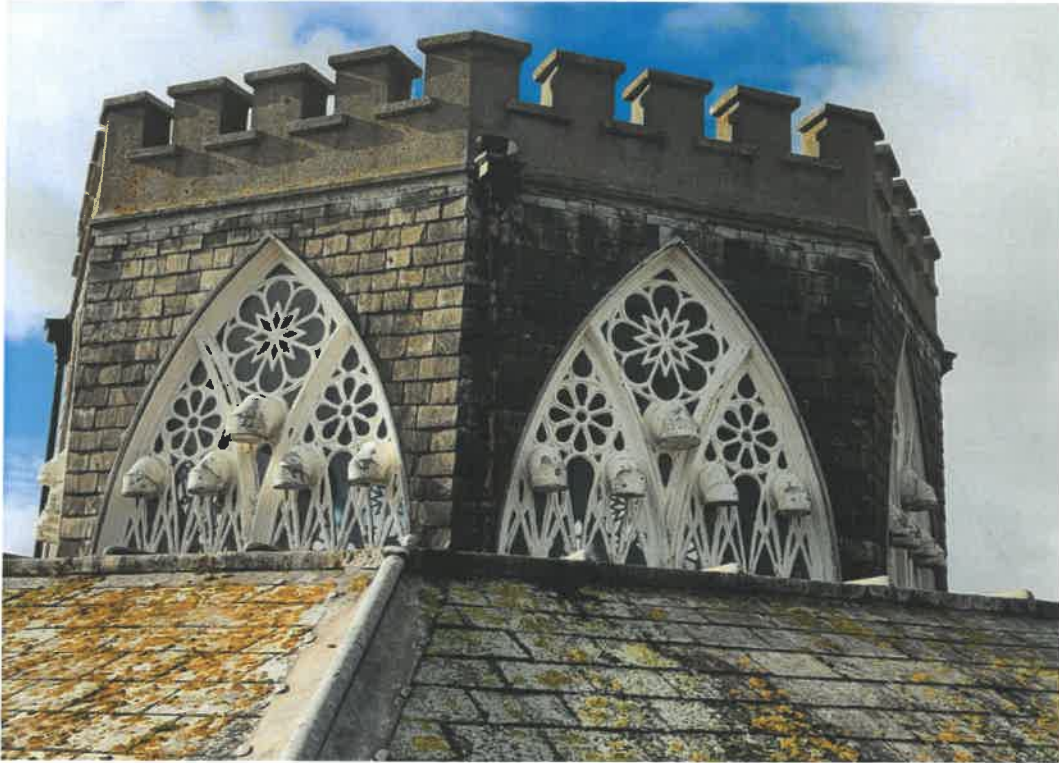
The flat area around the central lantern is covered with lead sheet. The previous Church Architect has noted that the lead is thinning and joints between the boards are showing through. The lead rolls are also developing splits at their ends and one has a temporary repair. On this occasion the area was not inspected as there was no safe access. A roof ladder with a handrail needs to be added to this area. **C**

08 Flat Area Around Lantern

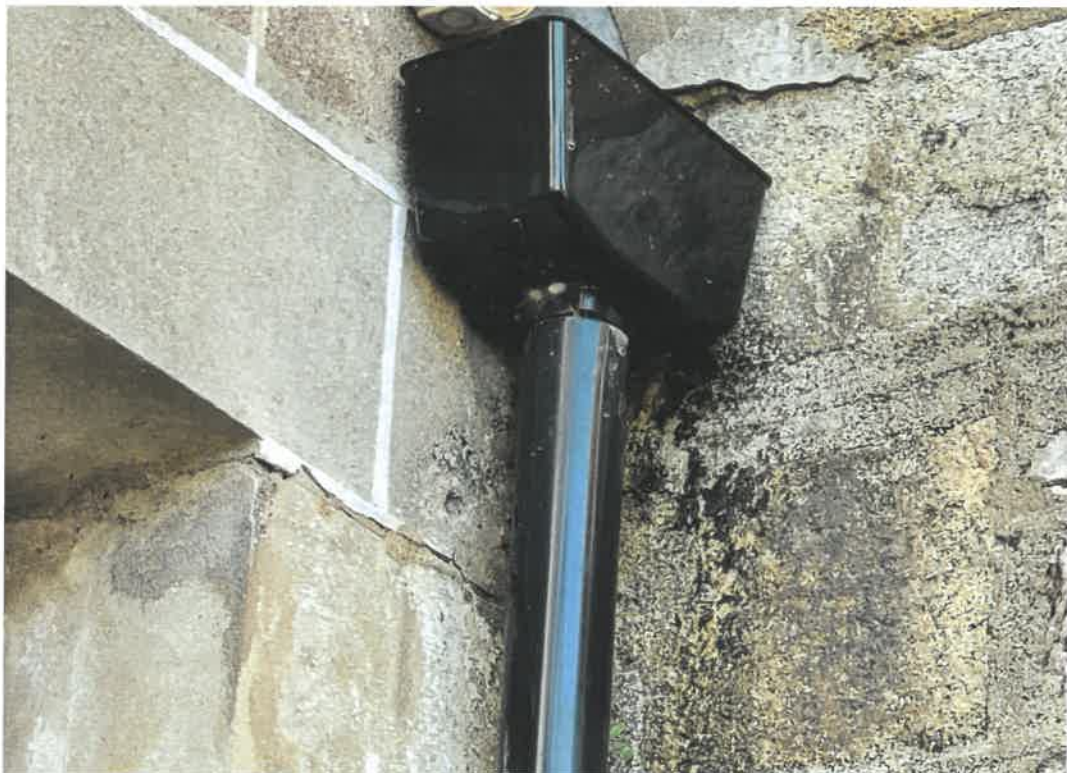
These are of cast iron and generally appear in satisfactory condition. Decorations are fair, but some rainwater goods require de-rusting and decoration, particularly to the vestry and lantern.

15 Rainwater Goods in need of Derusting and Decoration

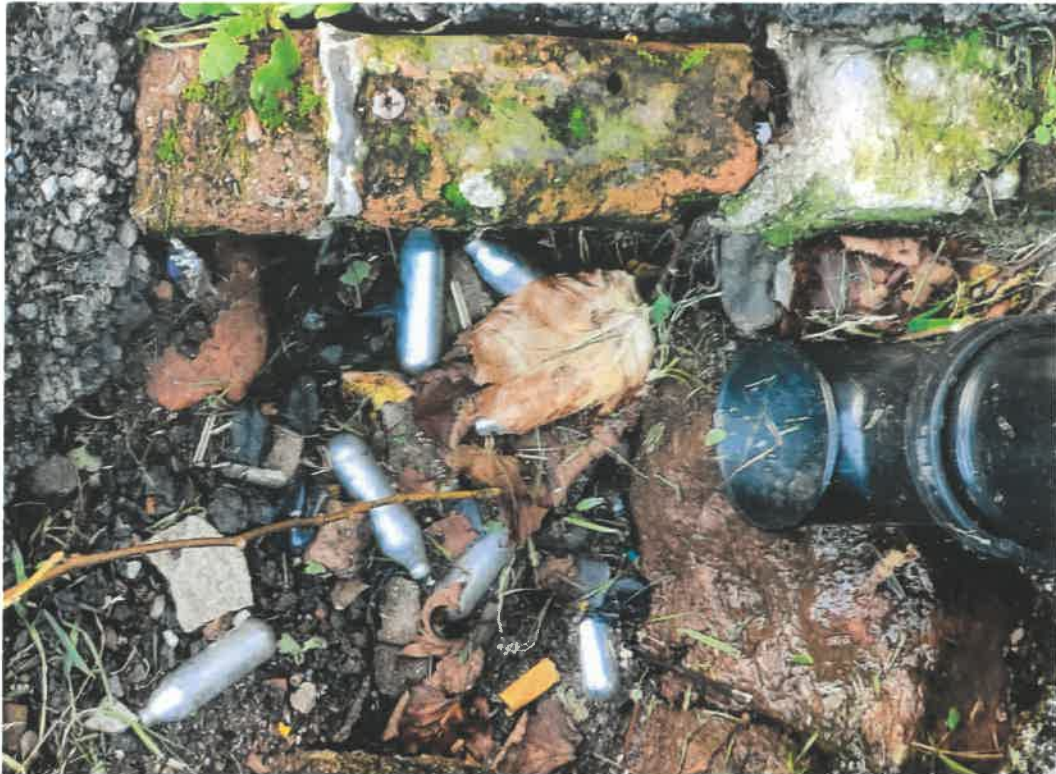
The vandalised south porch rainwater pipe has been replaced with a UPVC rainwater pipe. A replacement cast iron hopper and rainwater pipe would be a more pleasing option should the opportunity arise.

16 South Porch Hopper and Rainwater Pipe

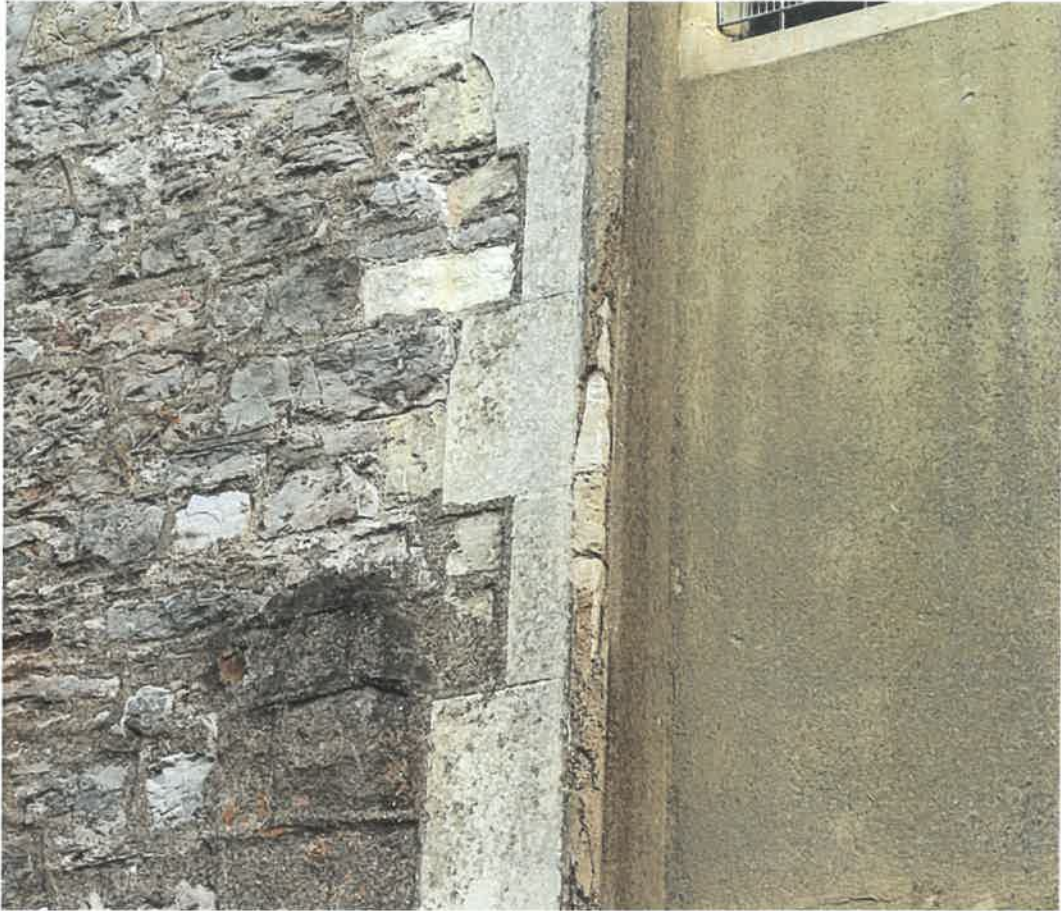
Render failing to corner turret.

20 Render Failing to Corner Turret

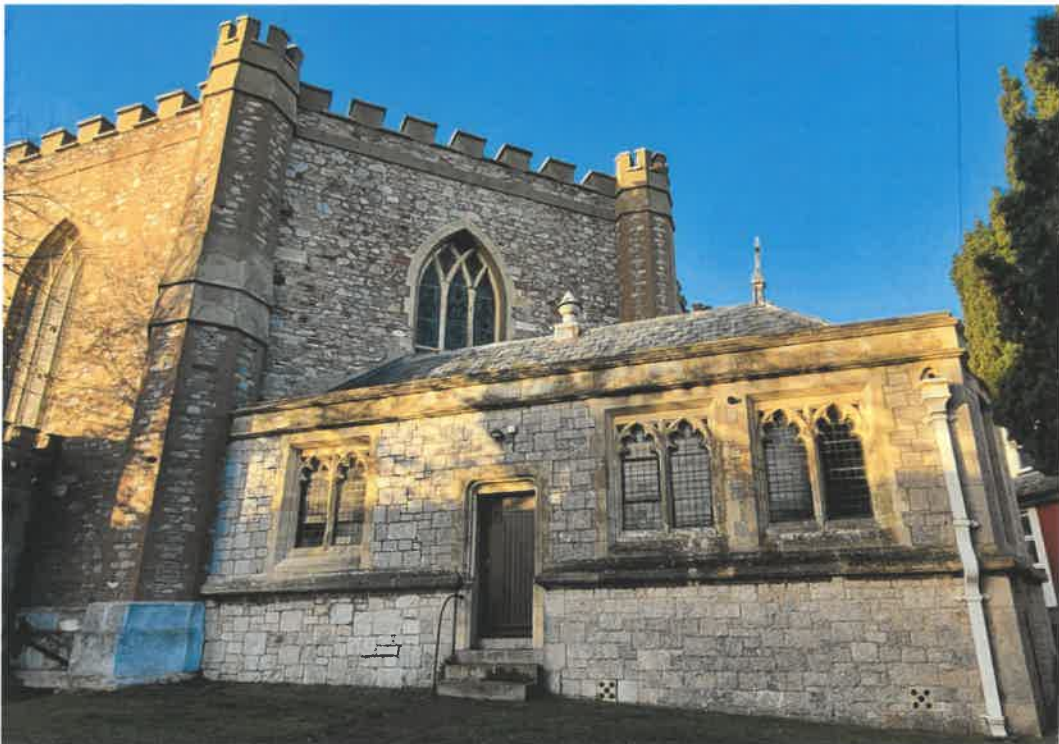
Render failing to window quoins.

21 Render Failing to Window Quoin

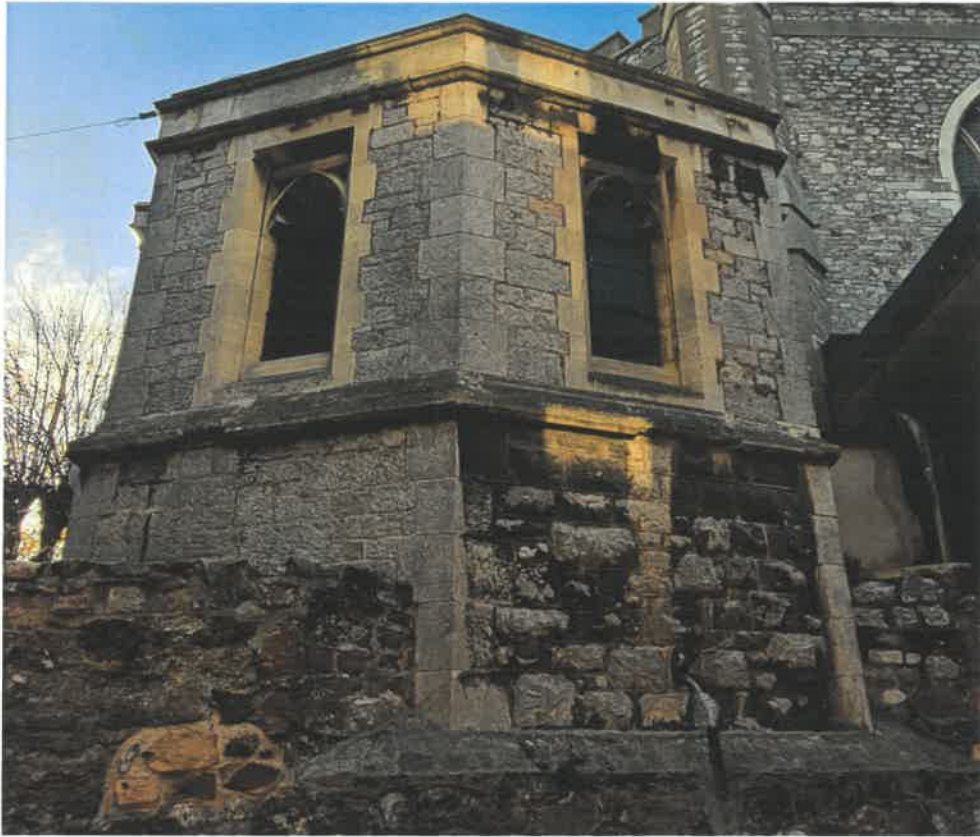
22 Whitford Room

Remove vegetation to steps and repair steps.
Image 22, 23, 24

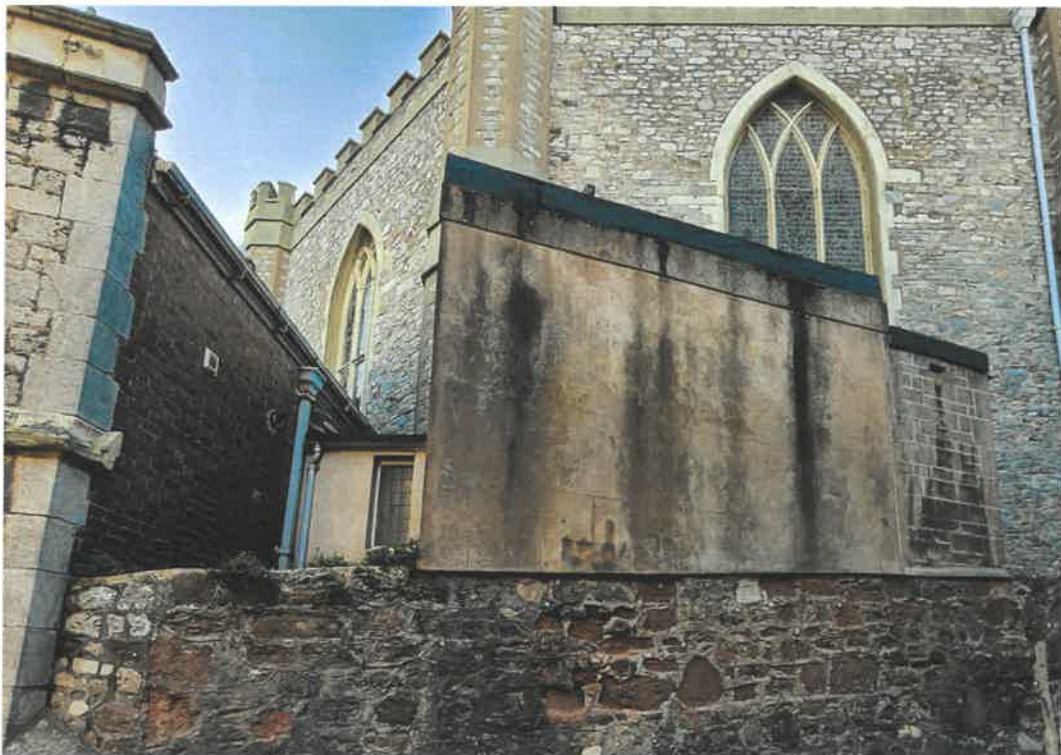
25 Vestry

There have been recent repairs to the north elevation.
Image 25, 26

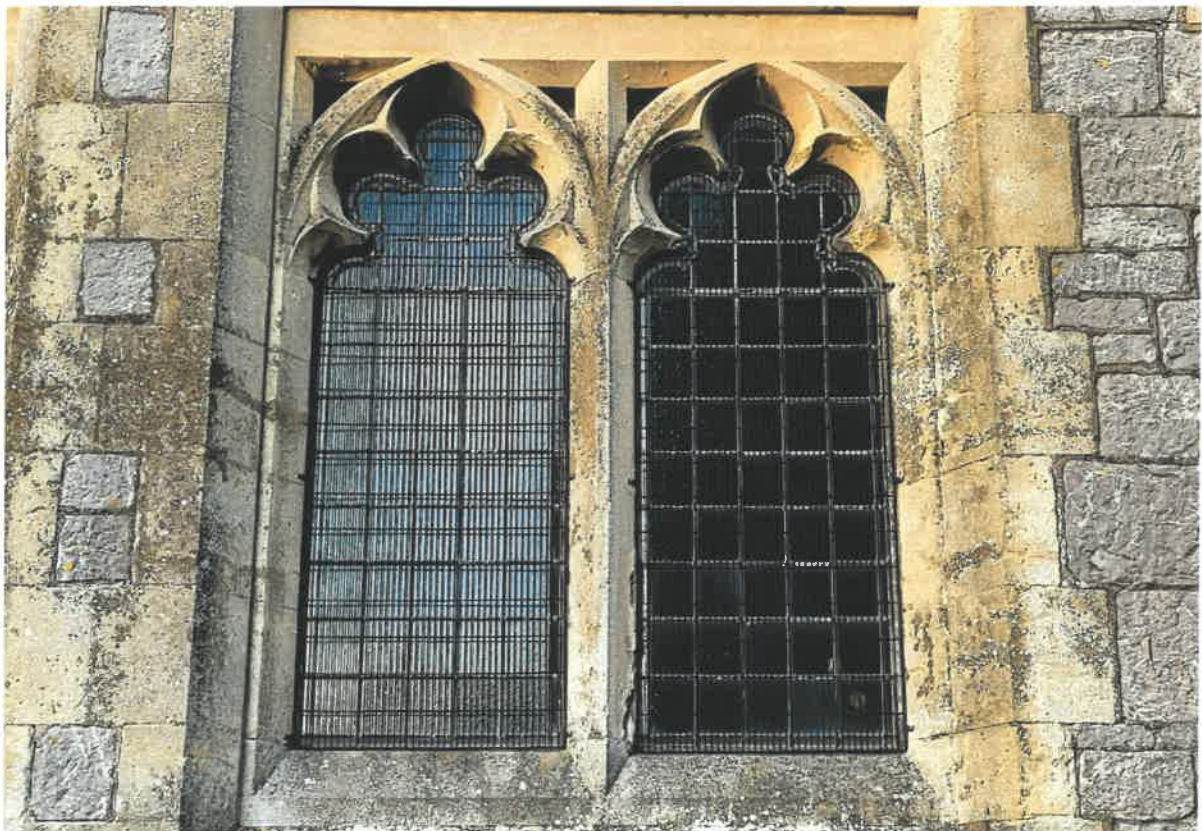
35 Window W5

In reasonable condition. Open joints around quoins require repointing.
Image 35

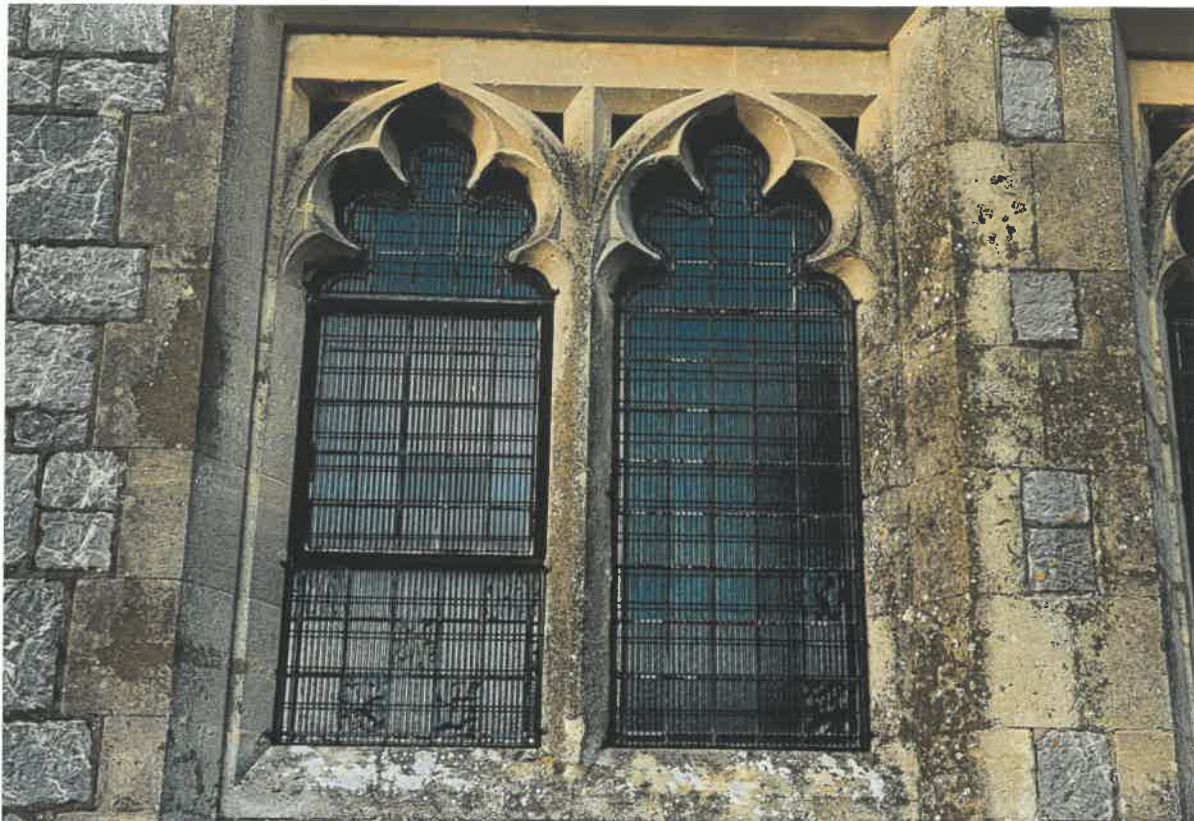
36 Window W6

<u>W6</u> Some erosion to central mullion. Plastic repair required. Image 36	C
<u>W7</u> Some erosion to central mullion. Plastic repair required. Image 37	C
<u>W8</u> Central mullion badly eroded. New piece of stone required. Repoint open joints to quoins. Image 38	B
<u>W9</u> Tracery badly eroded at high level. New piece of stonework required. Mullions not visible at lower level. Image 39	B
<u>W10</u> Minor erosion to masonry. Plastic repair required. Image 40	C
<u>W11</u> Tracery badly eroded at high level. New piece of stonework required. Mullions in poor condition lower down. Plastic repair required. Image 41	B
<u>W12</u> Erosion to mullions. New piece of stonework required at low level. Image 42	B
<u>W13</u> Much erosion to tracery and jambs. New piece of stonework required and plastic repairs. Image 43, 44	B
<u>W13A</u> Timber window needs repair to beads and redecoration. Remove weeds from cill and repoint. Image 45	B

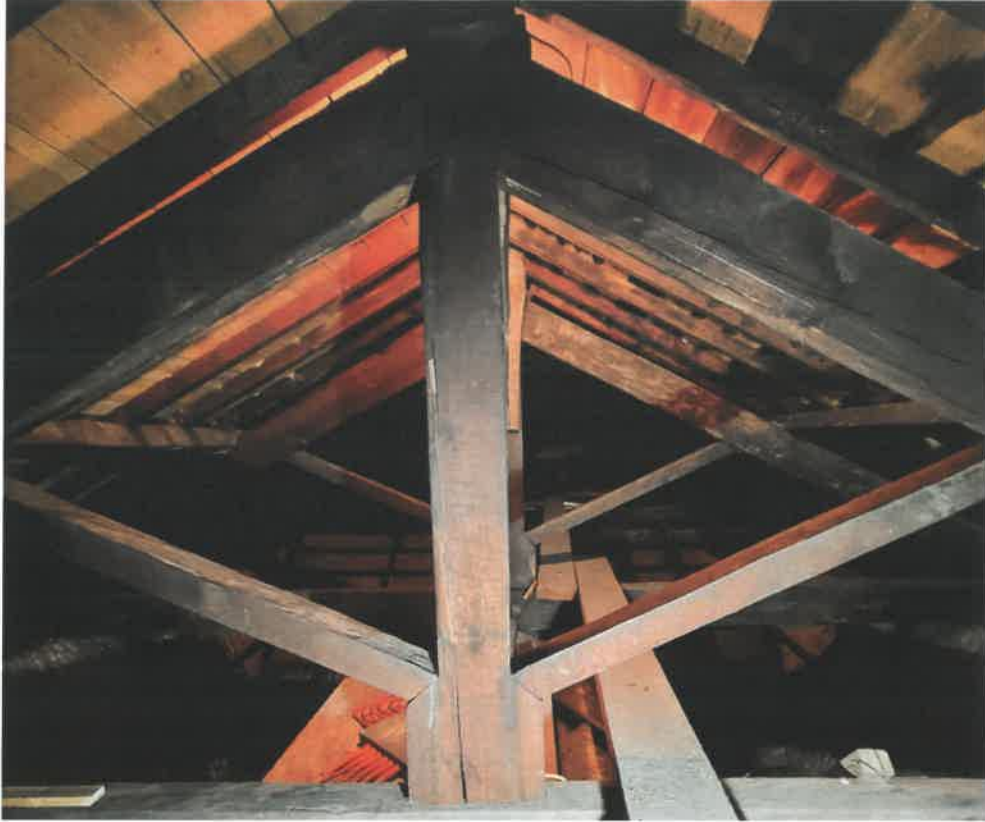
66 Nave Ceiling

Decorations are flaking on several ribs and staining on the ceiling in the south-west corner.

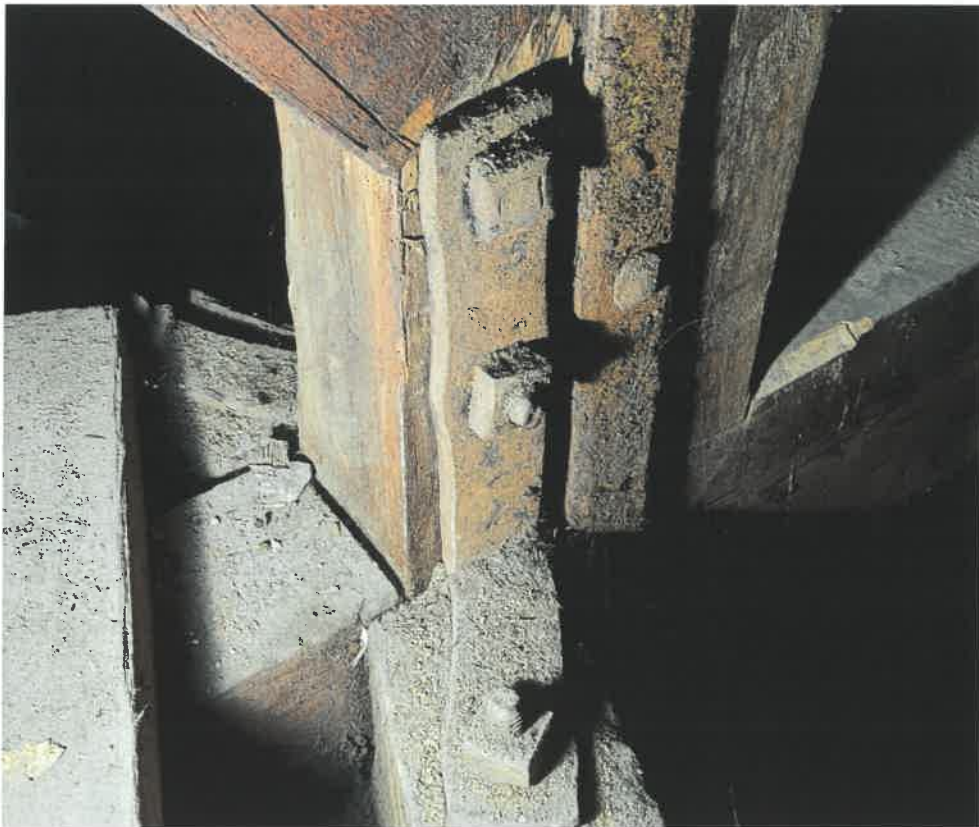
67 Roof Structure

The roof trusses are king post trusses. There are some signs of woodworm, but this may be historic. This needs to be monitored. The ironwork to the trusses needs de-rusting. **B**

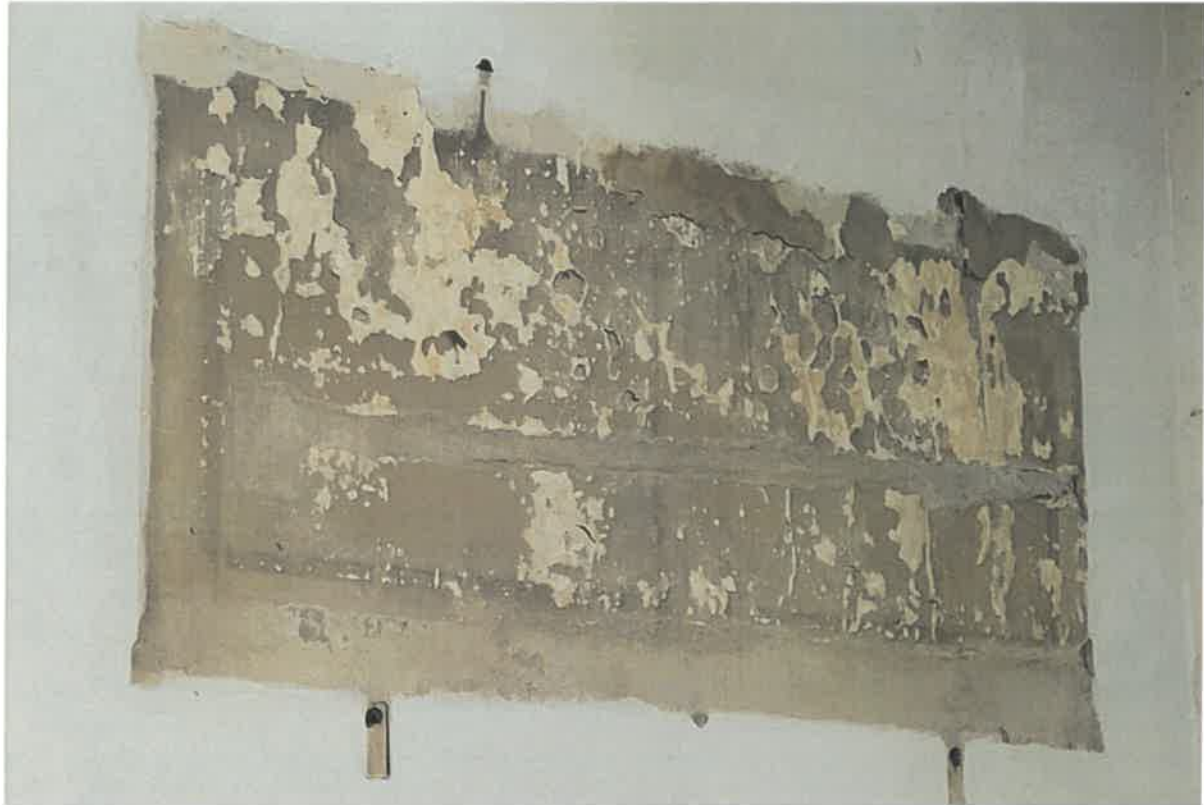
92 Monument where Lettering needs Repainting

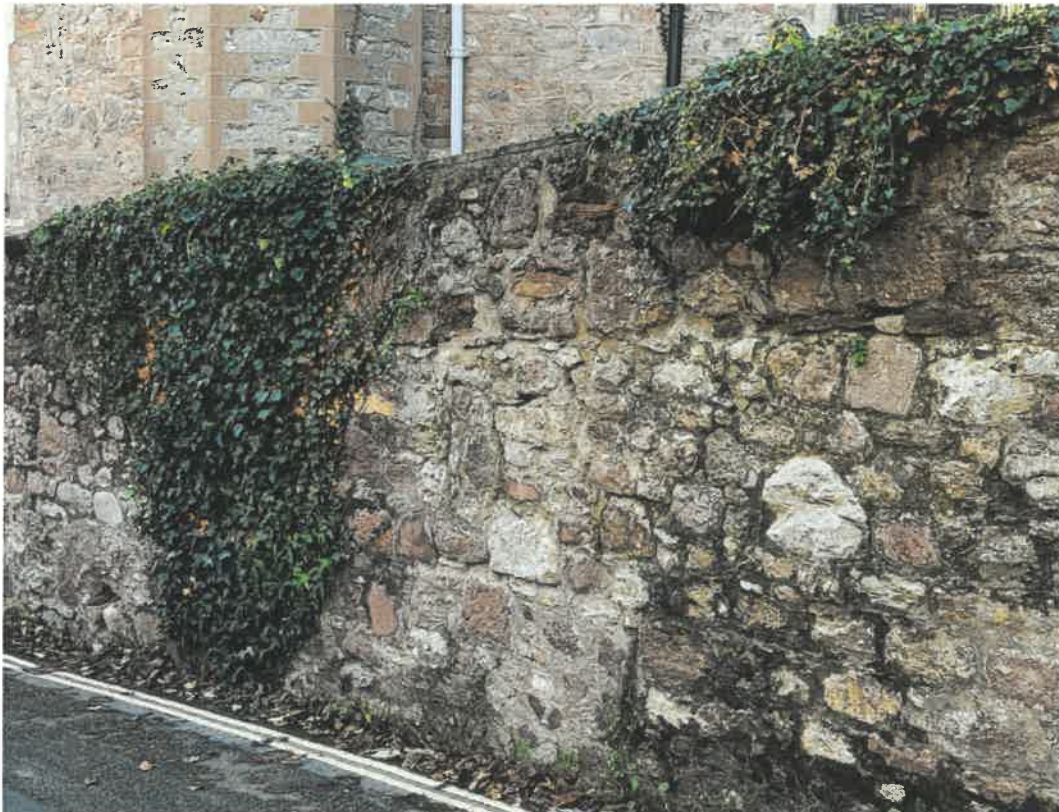
95 Churchyard North Wall

This wall is in fair condition with a few gaps in the copings.
