Report on the condition of the building following Quinquennial Inspection by
R. C. Palmer, Dip.Arch, Pg.Dip., A.A.B.C.

The Church of St. James the Less, Teignmouth, Devon

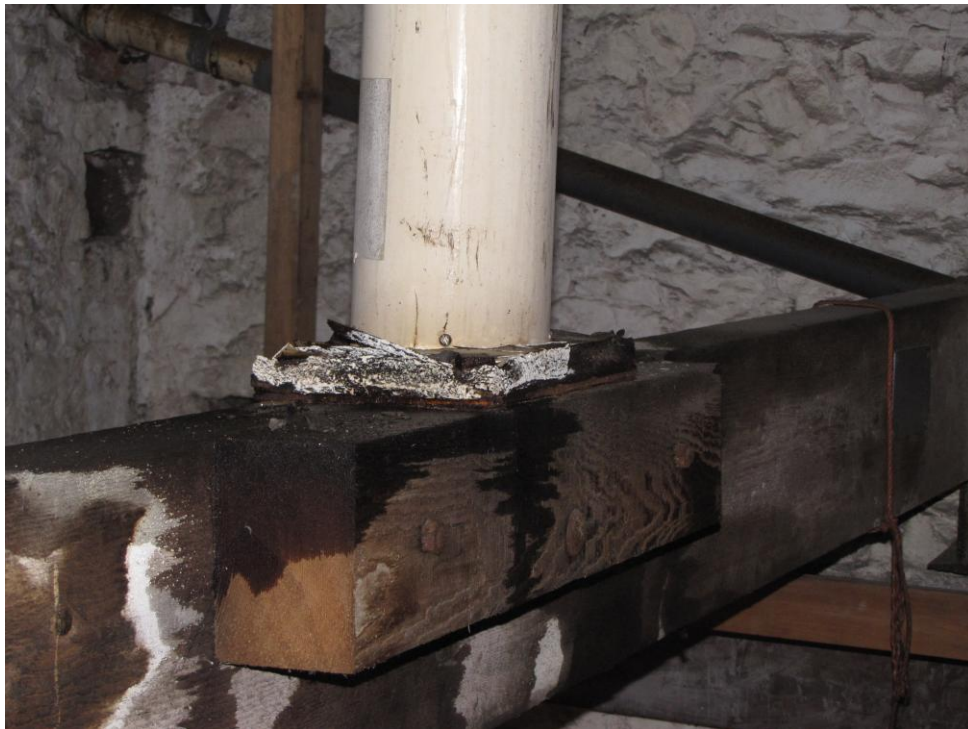
Photo 1

- a) This has a shallow pitched roof covered with lead sheet. It is of good thickness and well laid with an apron and capping to the low parapet walls. No defects were detected.
- b) There is a central fibreglass flagpole which only has a temporary flashing at its junction with the lead and this is defective, allowing water to pour through and cause decay to the flagpole support. (see photo 1)**U**

| b) | This leak is also causing delamination of the packing to the base of the flagpole and this will need renewal once the leak is repaired (see photo 1) | U |

- 1.1 Repair flagpole flashing (C.3.1b & 10.1a) MW
- 1.2 Temporary repair to split lead valley (C3.2d) MW
- 1.3 Replace link roof boarding and covering (D19.4 & C3.7b) MW
- 1.4 Unblock flat roof outlet in lightwell.* (C4.1c)
- 1.5 Unblock north gutter to Choir Vestry* (C4.1d)
- 1.6 Unblock hopper/r.w.p. to Porch * (C4.1e)
- 1.7 Check/unblock r.w.p. at south west corner (C4.1g)
- 1.8 Unblock lantern hoppers * (C4.1)
- 1.9 Unblock gully and clean other gullies* (C4.2a)
- 1.10 Clear drainage channel* (C4.2b)
- 1.11 Remove vegetation* (C6.2c)
- 1.12 Refix missing vertical slates (C7.9)
- 1.13 Repair window W8 (C9.1a)
- 1.14 Renew packing and fixing to flagpole (D10.1b)

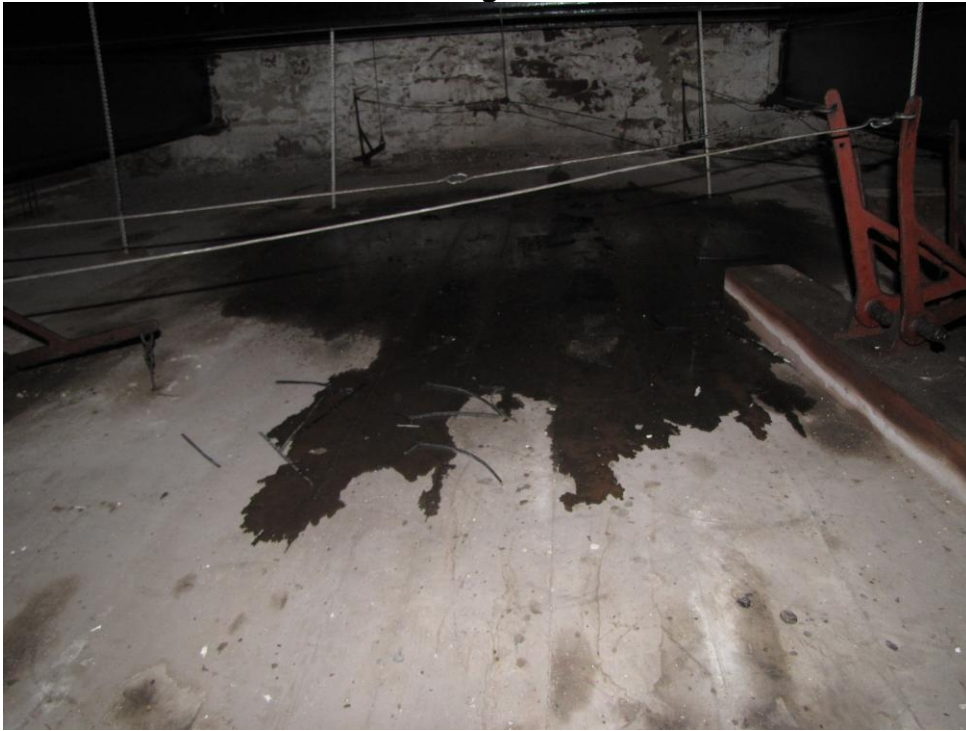
Photo 2

During the inspection water also flooded the bell chamber floor and penetrated the clock chamber below. (see photo 2)

| a) | The floor is substantial but is becoming wet from the leak around the flagpole, so a repair is needed urgently. (see photo 2) | U |

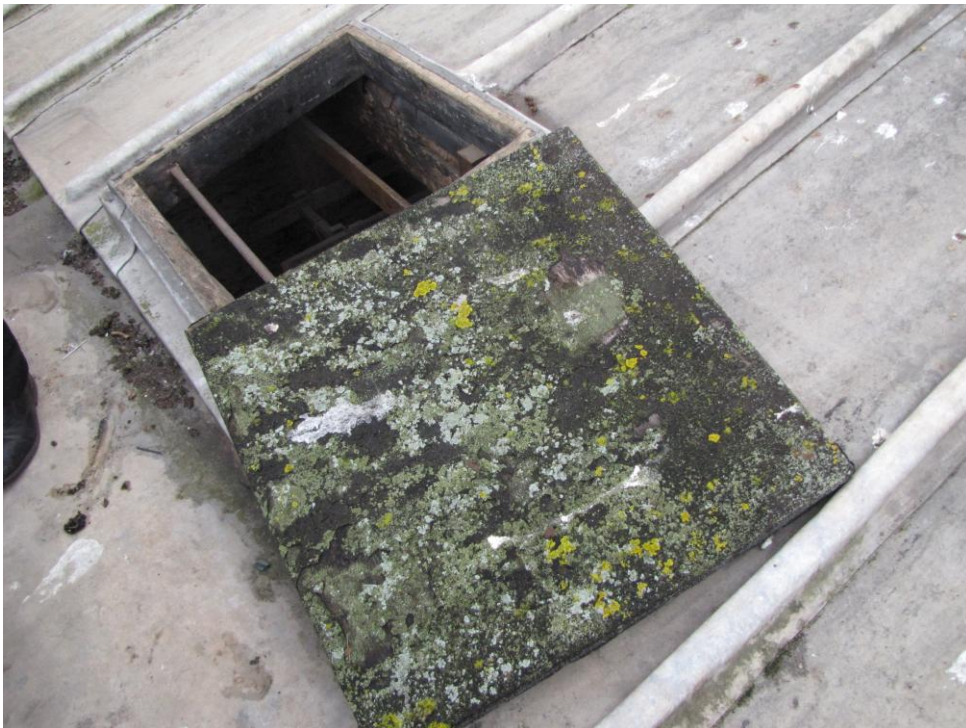
Photo 3

c) The access hatch is only covered with basic roofing felt and this needs replacing with more durable lightweight material as it is defective. (see photo 3)

- 2.24 Replacement lead to back gutter of Choir Vestry (C3.5c)
- 2.25 Replace covering to Tower roof hatch (C3.1c)
- 2.26 Redecorate doors and frame to window W3 (C8.1 & 9.1g)* MW

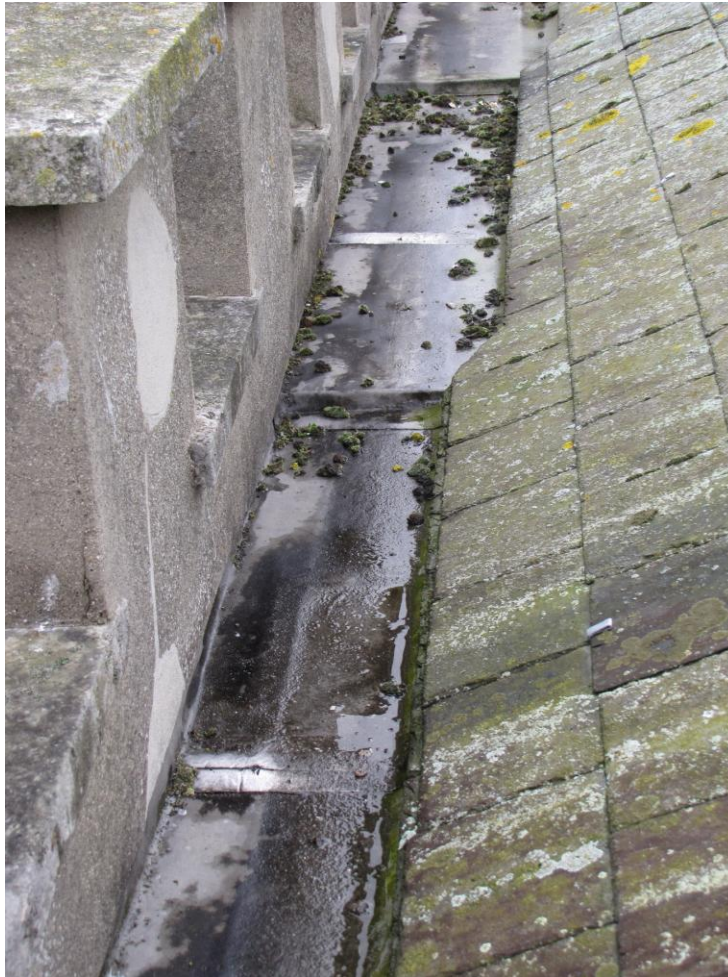
Photo 4

- b) The slates are Cornish and mostly in sound condition with only minor damage to a few.
- c) The parapet back gutters are covered in lead sheet and the bays are much too large causing numerous splits to develop. These have been temporarily patched with flashband but a permanent solution is now needed as these recurrent leaks are contributing to the dampness in the external walls (see photo 4)

- 2.1 Renew lead to roof back gutters (C3.2c)
- 2.2 Permanent repairs to sloping lead valley (C3.2d)
- 2.3 Repairs to lantern hips (C3.3b)
- 2.4 Investigate and rectify damp penetration (C3.2e, D12.1c)

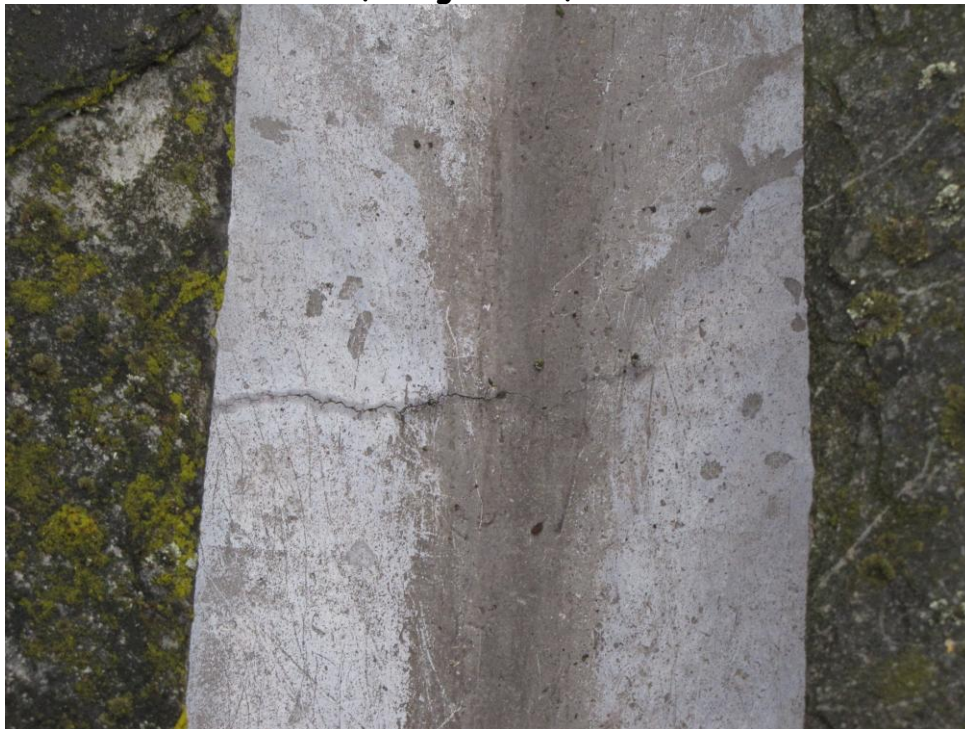
Photo 5

- d) The sloping lead valley gutter at the junction of the has been repaired temporarily in the past but now has 2 splits in different locations. (see photo 5)

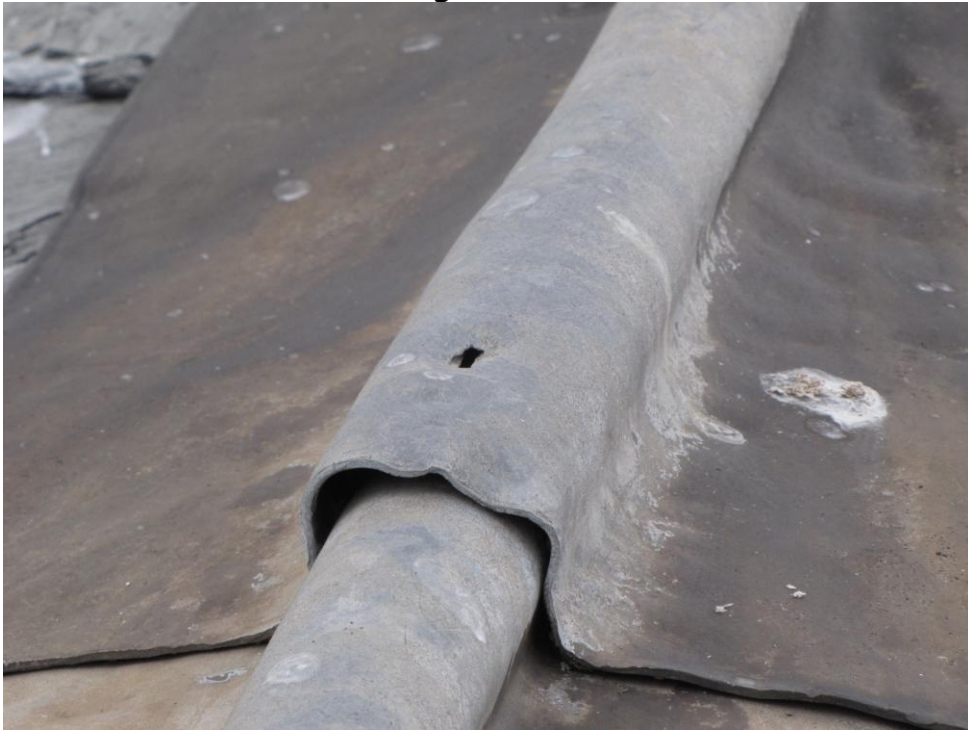
Photo 6

- a) This is of similar design and construction to the main roof with shallow pitched slopes covered with Cornish slate and lead covered parapet back gutters.
- b) The hips are lead rolled and have holes where fixing nails are missing. One has been repaired in flashband but permanent lead repairs are required. (see photo 6) 1

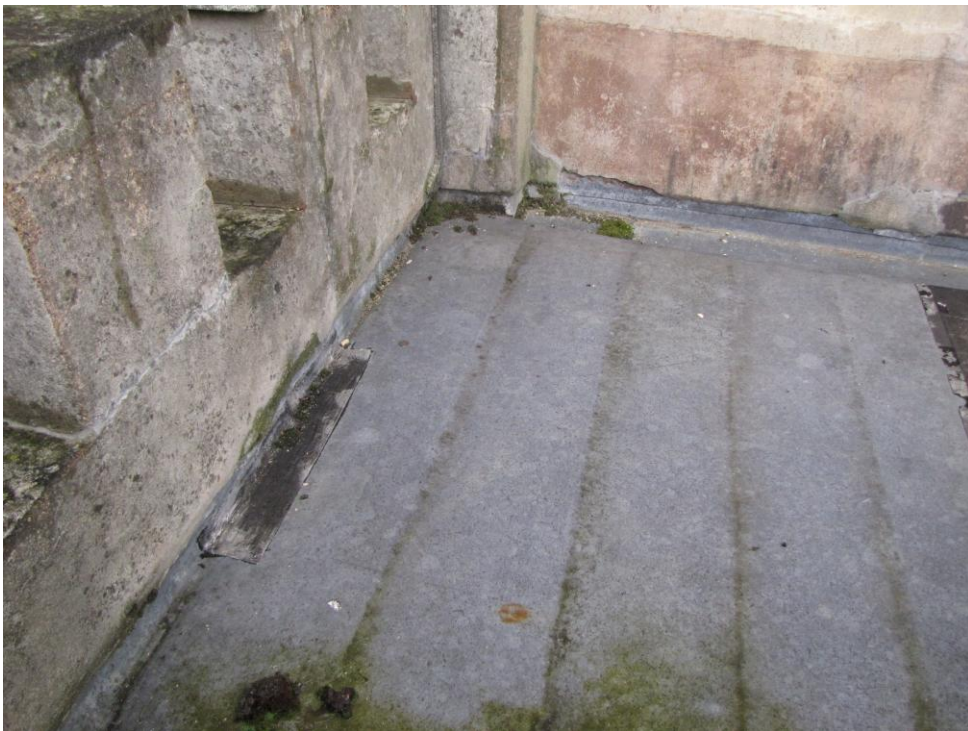
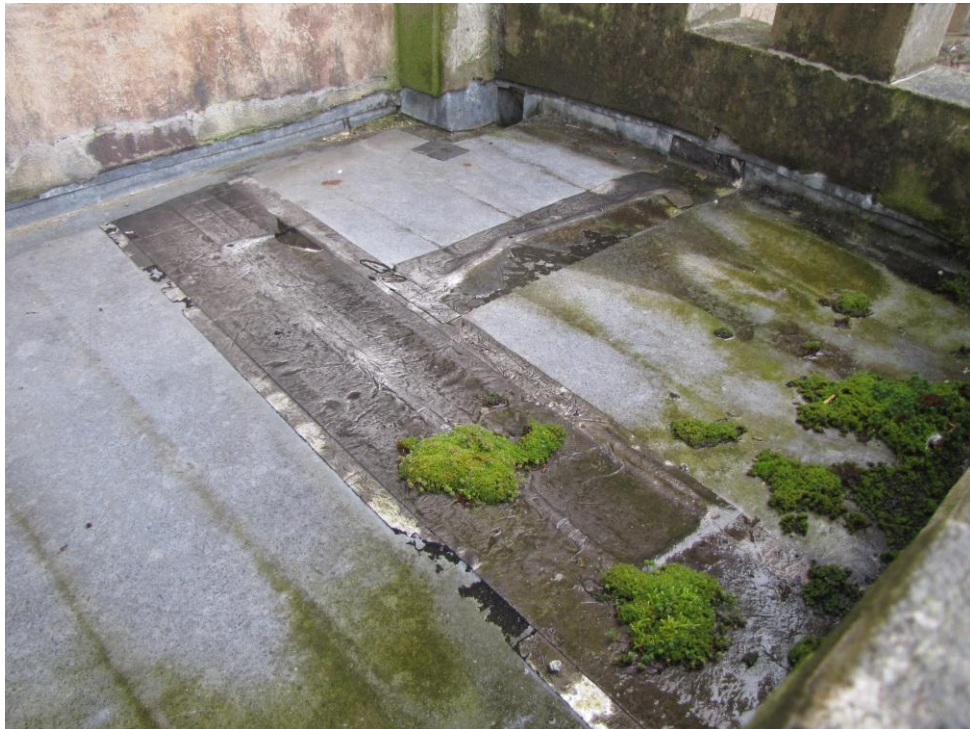
- a) The Porch roof is flat and covered with one sheet of lead.
- b) This is much too large and has consequently split and has been repaired temporarily many times. It needs replacing with new lead laid in smaller bays. (see photos 7 and 8)

- 2.20 Redecorate rainwater goods (C4.1a)
- 2.21 Repair and redecorate lantern windows (C9.1h)
- 2.22 Renew lead to Porch roof (C3.4b,D13.2)
- 2.23 Renew slate covering to Choir Vestry roof (C3.5b)

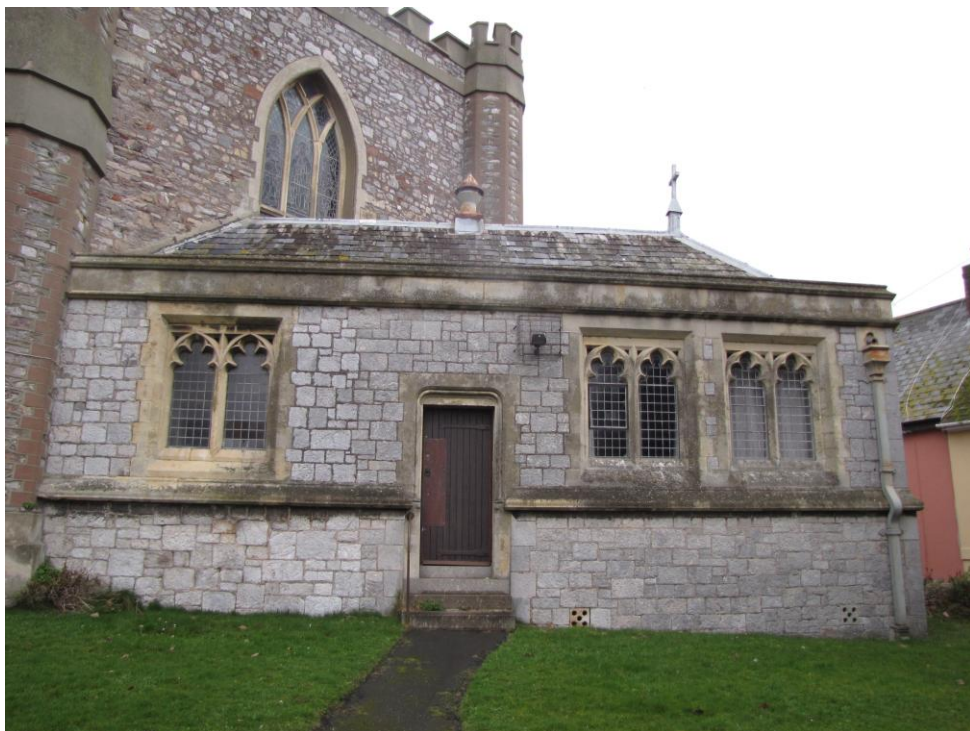
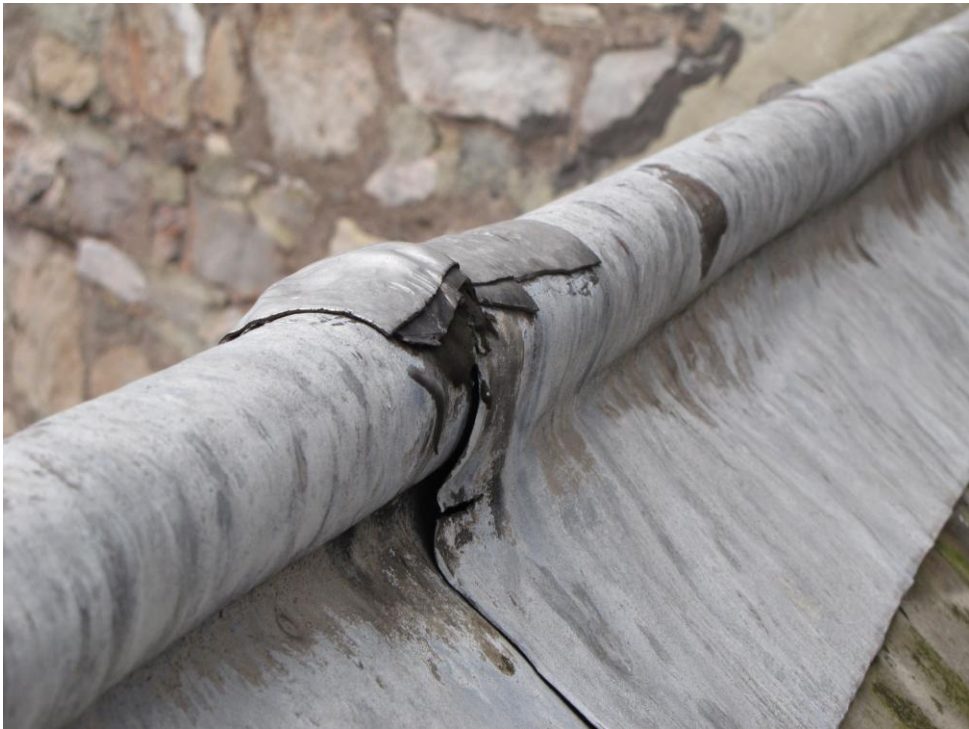
- a) This is pitched and covered with natural slates with a lead covered parapet back gutter on the south and east sides.
- b) The slates and lead ridge are in poor condition with many missing and clipped slates and it needs completely recovering. (see photos 9 and 10)

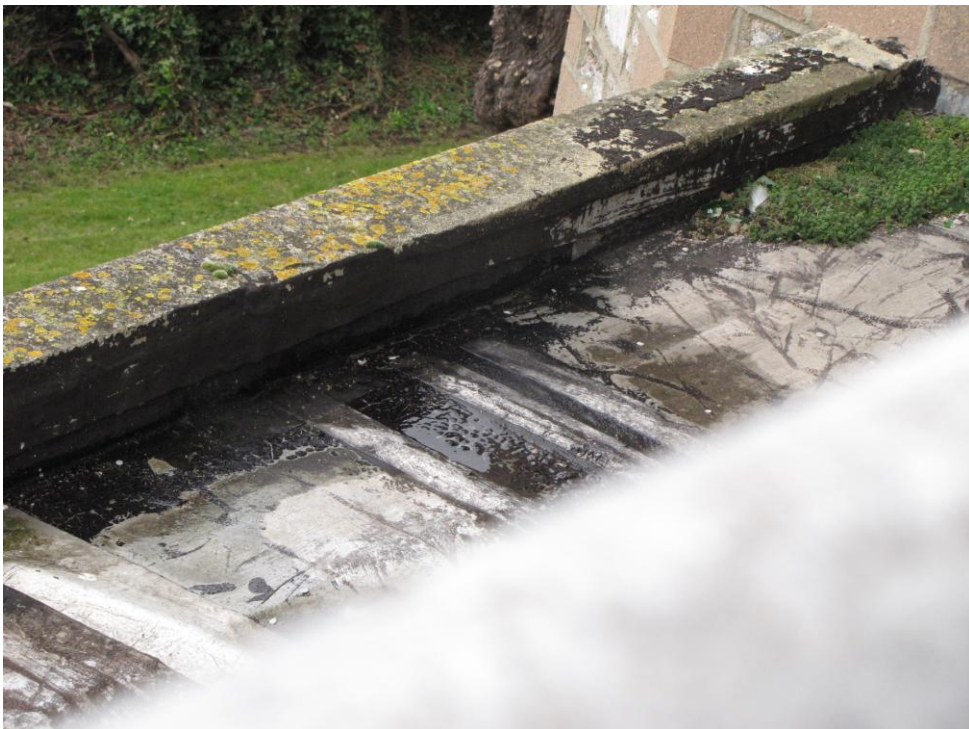
Photo 11

- c) The parapet back gutter could not be inspected at close quarters as a ladder was not provided but as viewed from the ridge it is apparent that the highest bay is much too large and the lead is defective and needs replacing. (see photo 11)

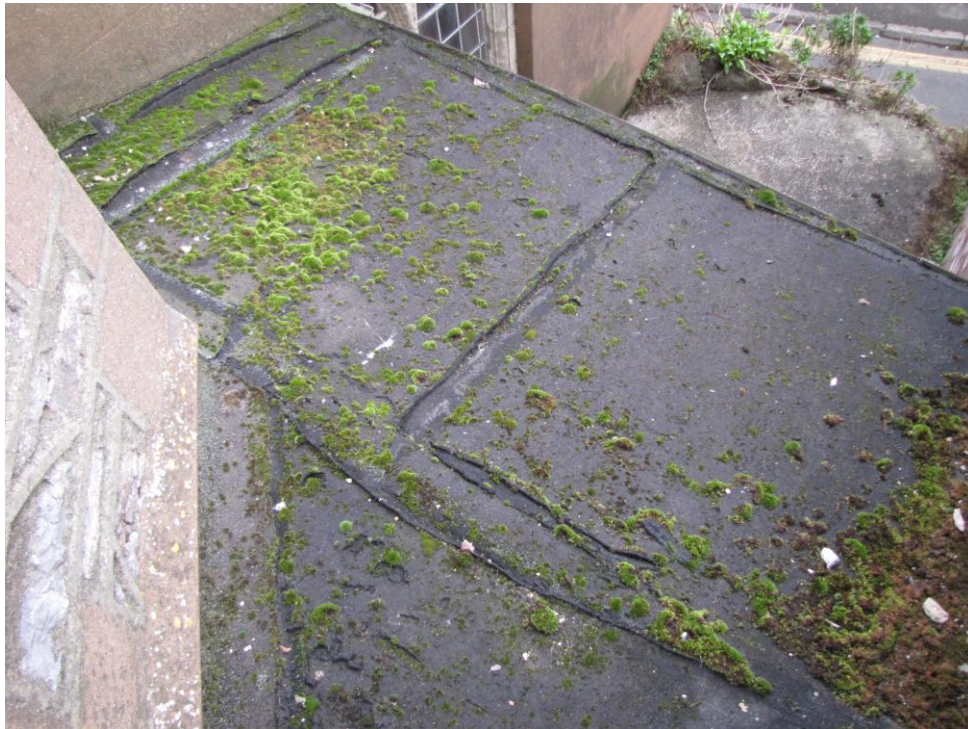
Photo 12

- a) This has a shallow pitched roof which is covered with basic roofing felt.
- b) This is cracked and splitting and leaks are causing damage to the roof structure below. (see photo 12)

| 19.4 | The roof to the link corridor has defective structural boarding and this partially collapsed under my weight during the survey. | U |

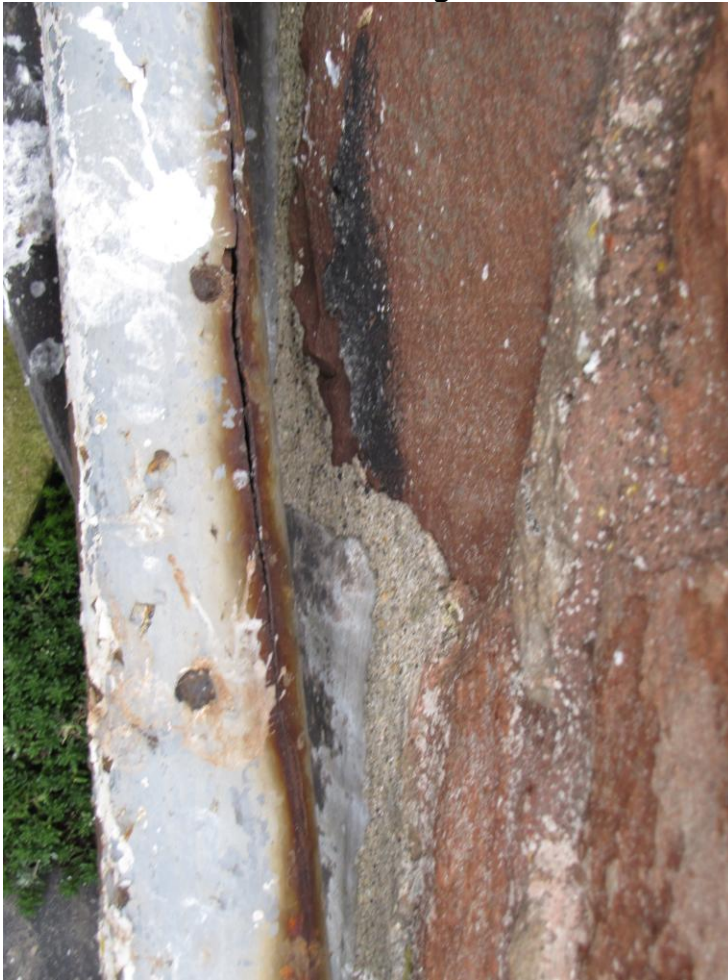
Photo 13

- a) These are mostly cast iron and in reasonable condition, although redecoration is required. 1
- b) The Tower roof drains to 2 rainwater pipes and these run internally through the bell chamber and then diagonally to the back gutters. The pipe on the south side is split and needs replacement, contributing to the damp in the wall below (see photo 13) 1

- 2.9 Repair lime plaster plinth (C7.2)
- 2.10 Remove ivy * (C7.3) MW
- 2.11 Clear vegetation, etc.* (C7.11) MW
- 2.12 Replacement of cracked Tower r.w.p (C4.1b)

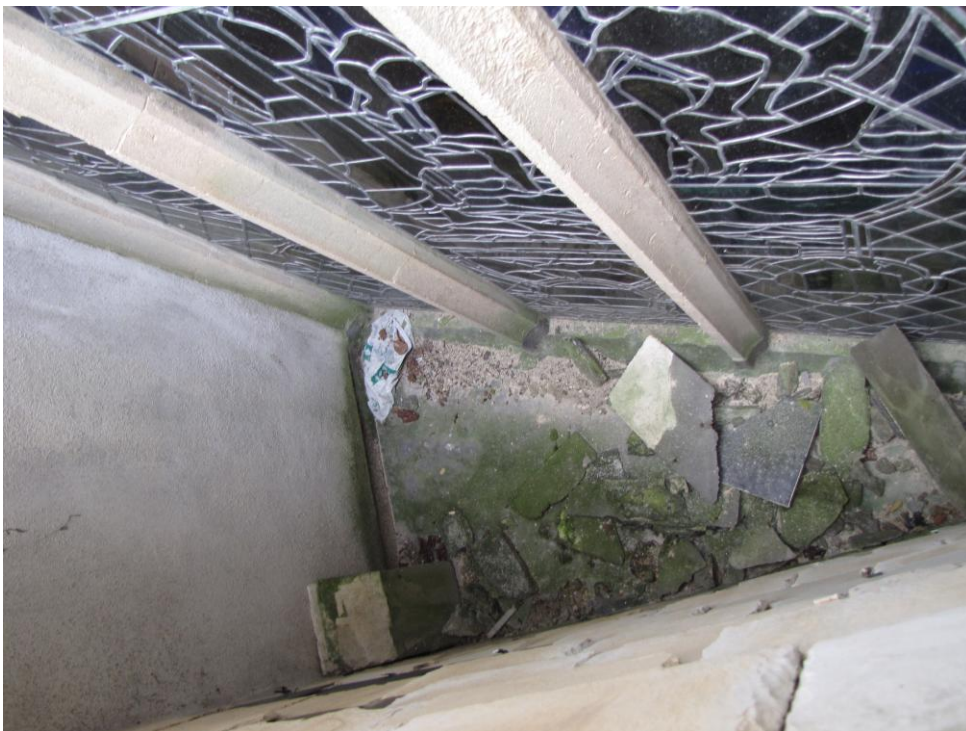
Photo 14

- c) The roof outlet to the flat roof in the light well by window 9 is blocked by slates that have fallen off the walls. (see photo 14)

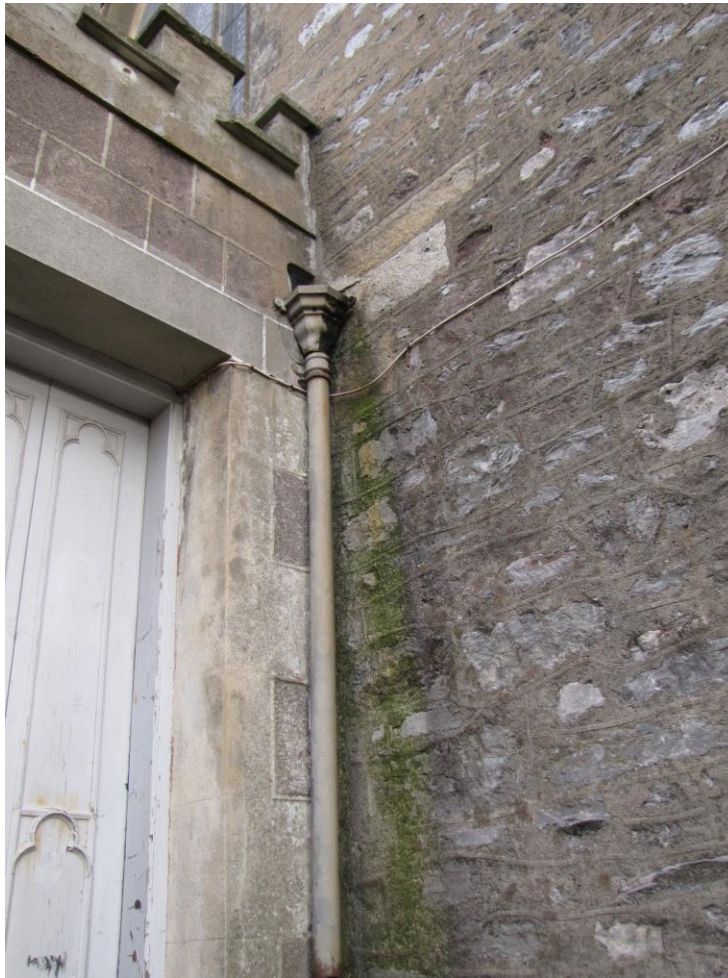
Photo 15

- d) The north gutter to the choir vestry is blocked by weeds and needs clearing. U
- e) The hopper or rainwater pipe to the Porch roof appears blocked, causing overflows and dampness in the adjacent Church wall. (see photo 15) U

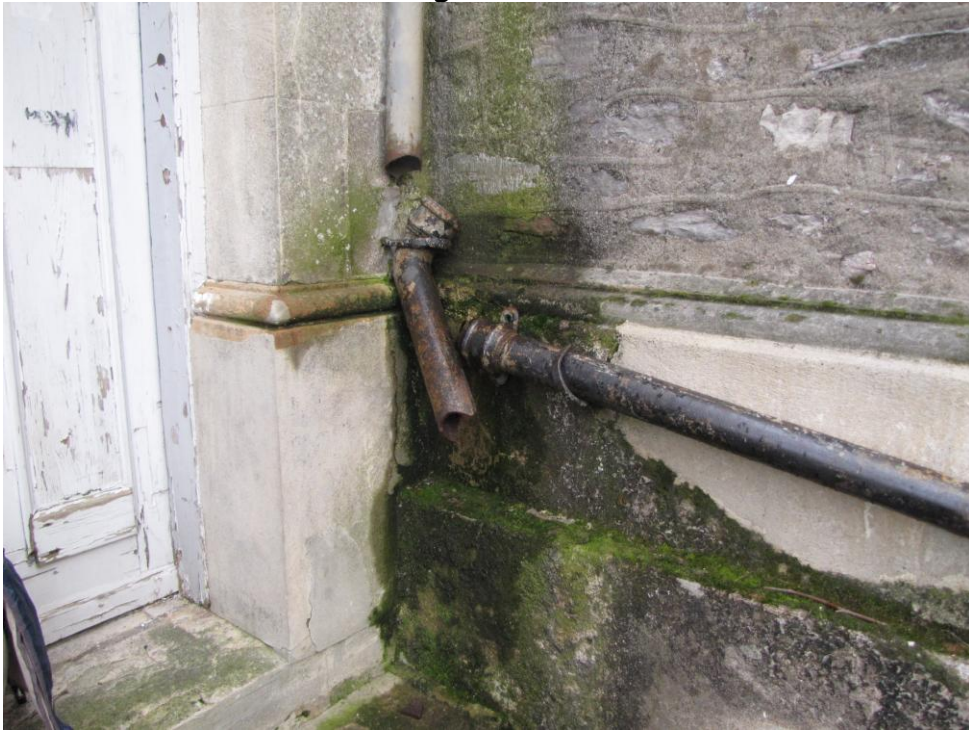
Photo 16

- f) The bottom of this same pipe is broken, also adding to the dampness in the walls. (see photo 16)

- 2.13 Replace broken r.w.p (C4.1f)
- 2.14 Repair or replace section of r.w.p. at south west corner, if needed (C4.1g)
- 2.15 Refix lantern r.w.p (C4.1k)

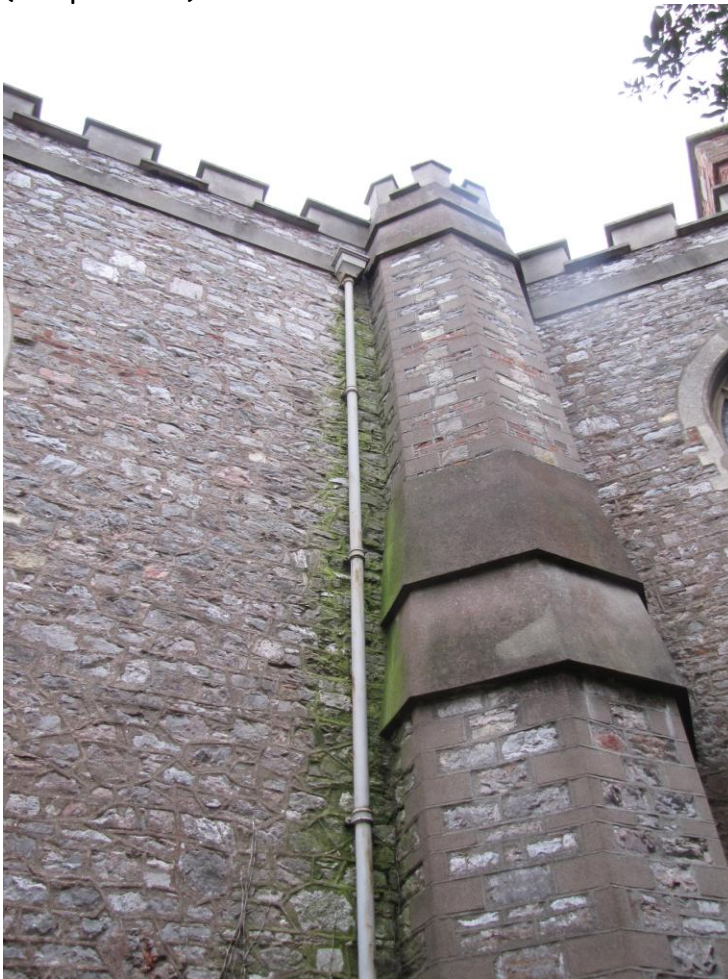
Photo 17

- g) The hopper or downpipe to the west of the buttress at the south west corner appears cracked or blocked, adding to the dampness in the walls. (see photo 17)

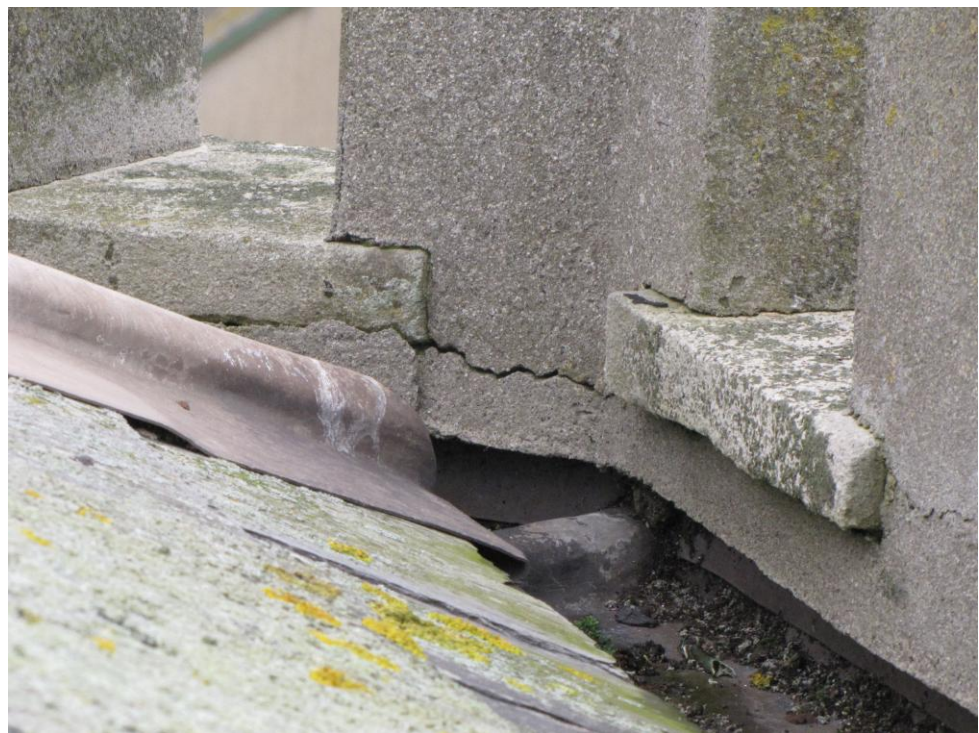
Photo 18

- a) This has embattled rendered parapet walls similar too the main walls and with the same problems. D
- b) Some of the copings are made up in 4 pieces, with joints that need repointing. Ideally these should be replaced with single pieces of stone. 1/D
- c) There is cracking in the render at the north east corner. (see photo 18) 1

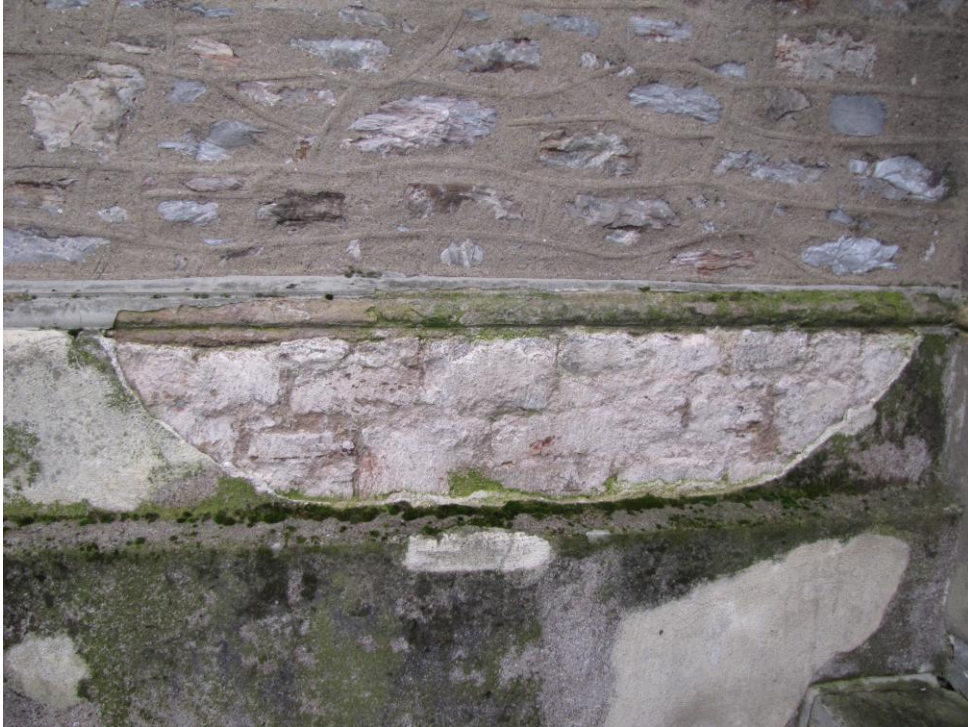
Photo 19

- 7.2 The plinth to the south walls appears to retain some of the original lime plaster, but this has been repaired badly in places, has cracks at its junction with the main wall above and has some missing sections (see photo 19)

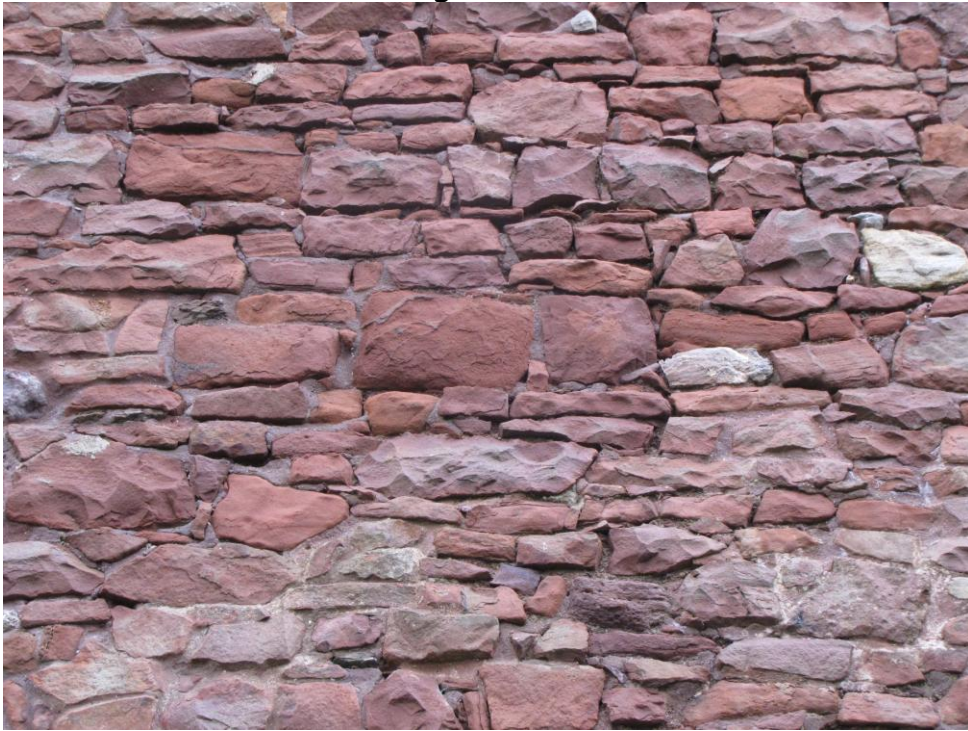
Photo 20

- 7.3 Some ivy needs clearing from the north wall.
- 7.4 The Tower walls are constructed of a random mixture of local red sandstone and volcanic stone. It is in good condition but some of the west wall will need repointing in due course. (see photo 20)

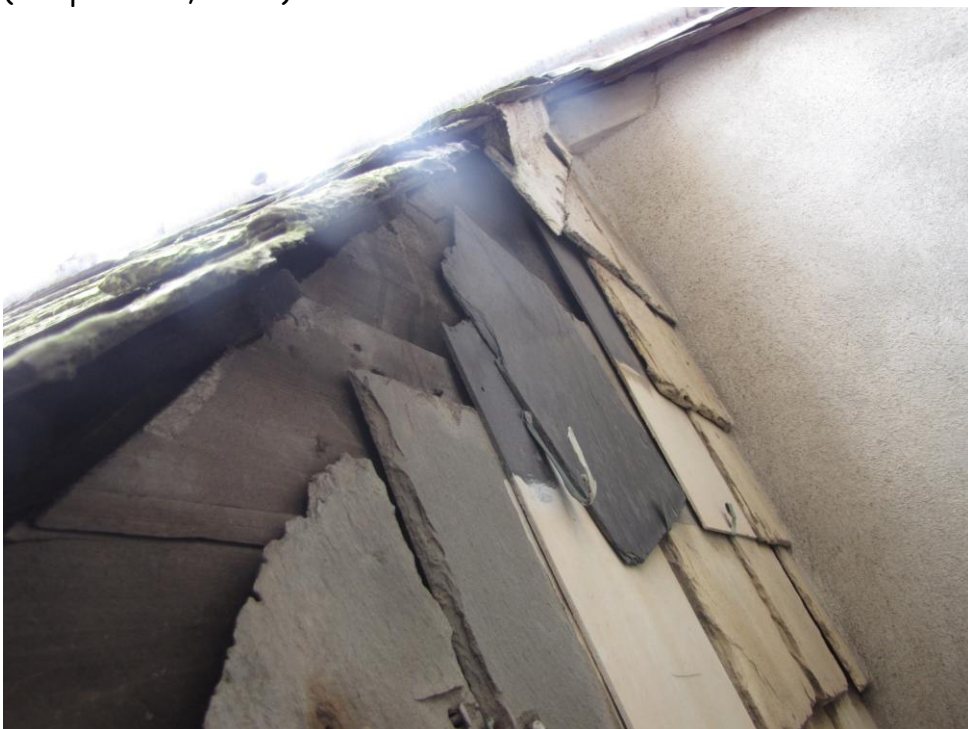
- 7.5 The plinth and moulded door surround to the west wall of the Tower are painted in a white paint which is not suitable for masonry or render and is flaking.
- 7.7 The Choir Vestry south and east walls are faced with coursed limestone and are in good condition.
- 7.8 The north wall of the Choir Vestry and the east wall of the link corridor are of brick; the faces of some bricks to the latter are delaminating.
- 7.9 The east wall of the link corridor, over the light well, has slate hung cladding. this is in very poor condition with a number of slates missing. (see photo 21, below)

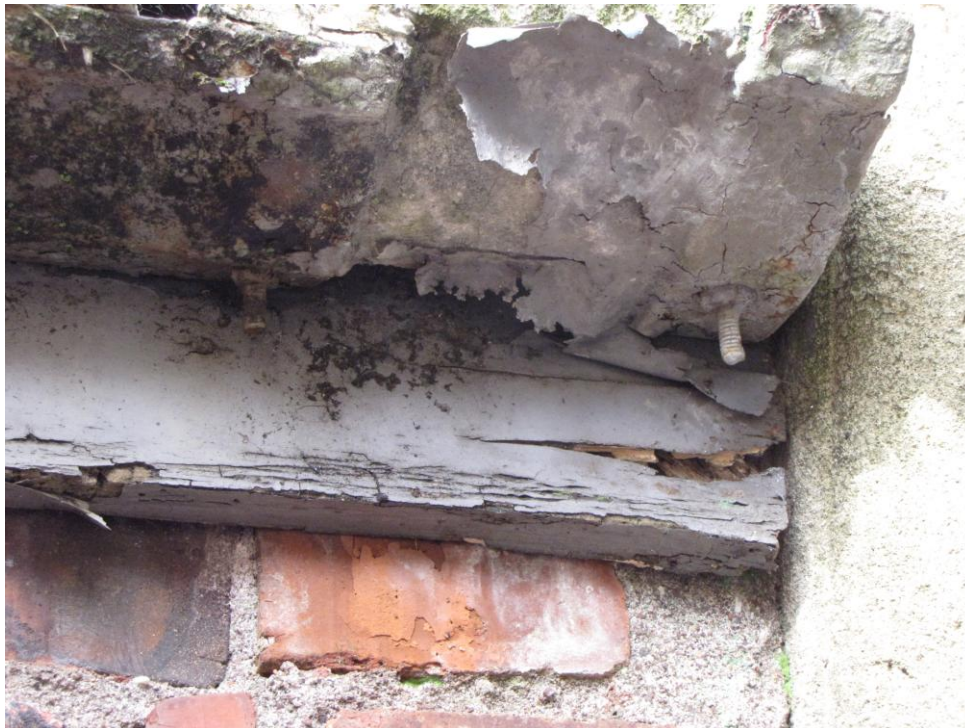
Photo 22

| 8.2 | The fascia to the link corridor is rotten and needs replacing. (see photo 22) | 1 |

- 2.27 Replace rotten fascia (C8.2)
- 2.28 Redecorate window opening lights (C9.1f)
- 2.29 Repair Tower ladder (D10.3c)
- 2.30 Comply with Fire Safety Regulations (D27.1b)

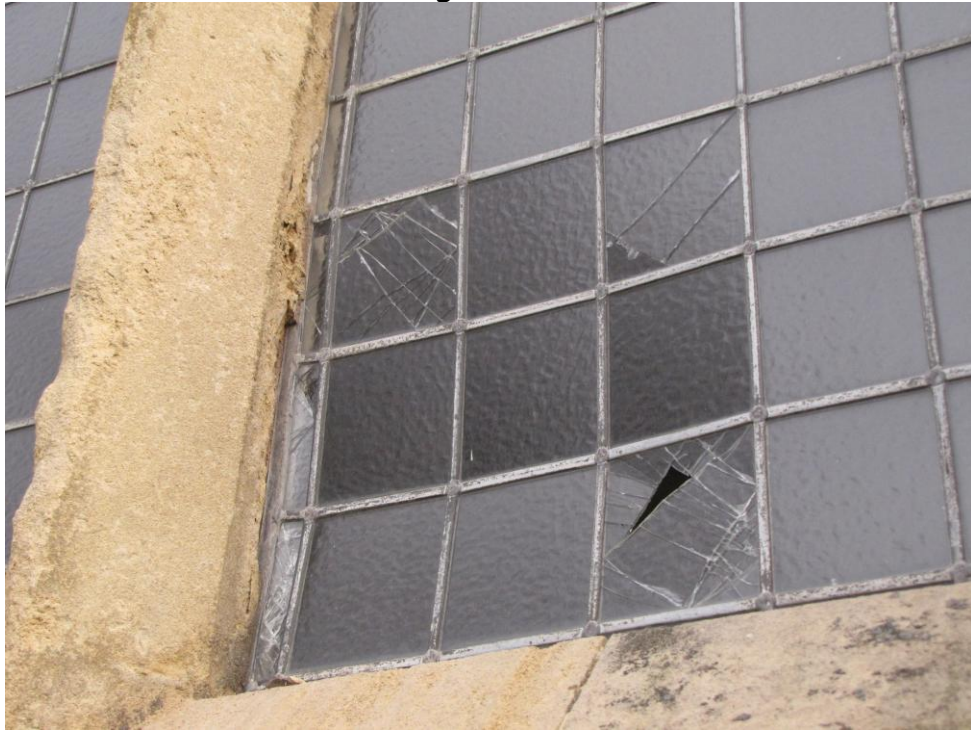
Photo 23

- a) The panes of W8 have been damaged by vandalism and the lead comes are displaced. (see photo 23)

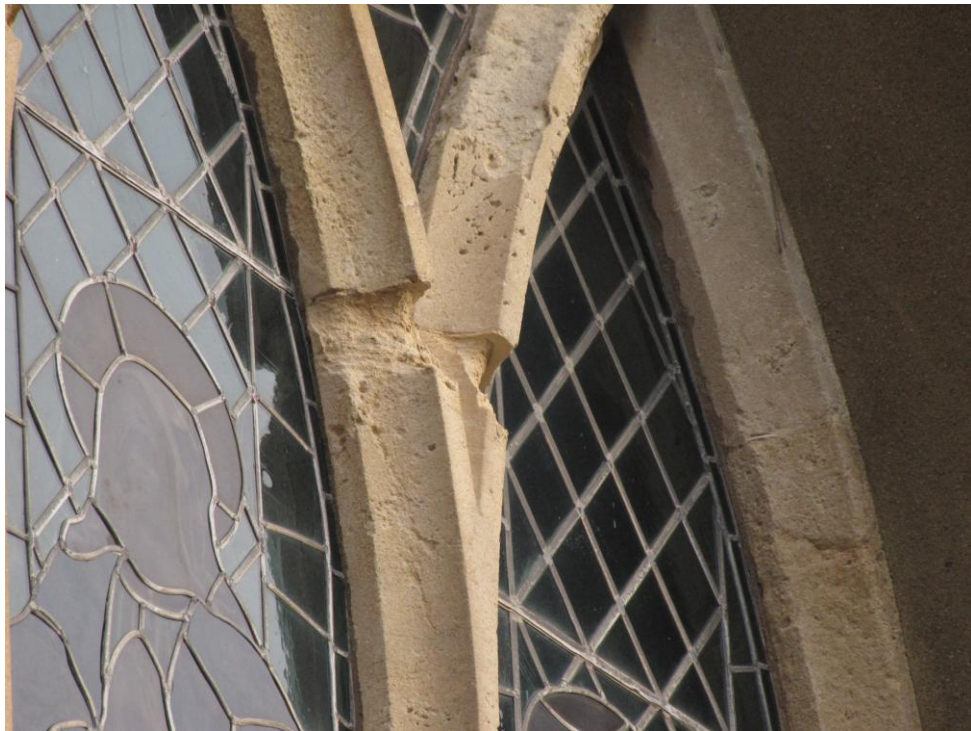
Photo 24

- b) The masonry to this window would benefit from protection by the lime method.
- c) The tracery of W9 and W12 needs repair (photo 24 shows W9)

- 3.1 Repair tracery to W9 and W12 (C9.1c) MW
- 3.2 Replastering and redecoration of internal faces of main external walls, subject to drying (D17.4)
- 3.3 Repairs to dado boarding, in conjunction with 3.2 above (D17.6)
- 3.4 Electrical Test and Report (D24.2)
- 3.5 Further boundary wall repairs (E34.1b & 34.3b +c)
- 3.6 Conserve/isolate reredos (D18.2)
- 3.7 Check under Vicar's Vestry Floor (D19.5)* MW

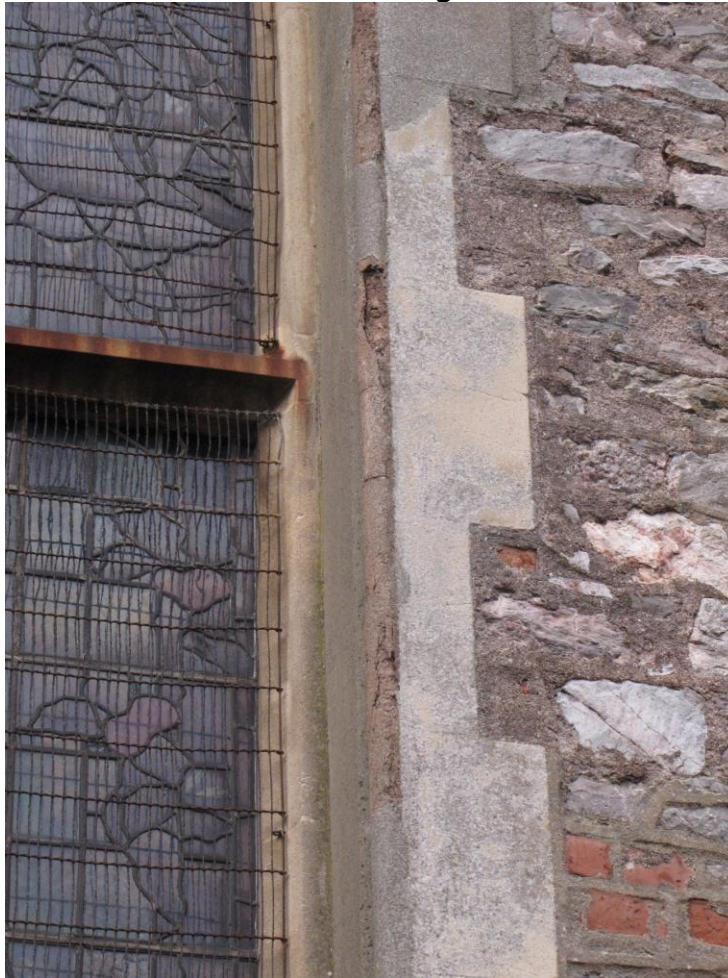
Photo 25

- d) The window reveals are mostly plastered and this is defective at the outer bead moulds in several windows. (see photo 25)

| e) | As can be seen in photo 25 several of the masonry transoms are badly stained by rusting protective grilles. | D |

- 2.5 Treat woodworm in roofspace (D12.1b)
- 2.6 Refix displaced purlin prop (C12.1a)
- 2.7 Repoint walls or cover with lime stucco (C7.1)
- 2.8 Repair window bead moulds (C9.1d) In conjunction with 2.5

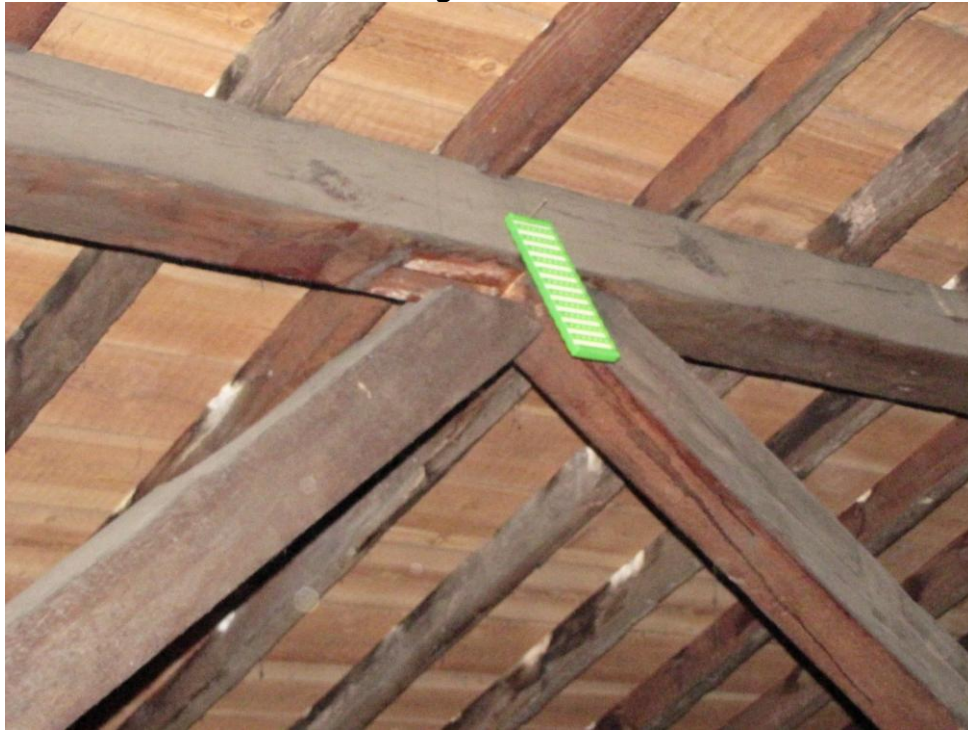
Photo 26

- a) This was inspected using the crawl boards provided and no major defects were seen. The rafters are 125 x 50mm at 500mm centres and support timber boarding below the slates.
On the north side, however, the prop to one of the purlins has become displaced and needs refixing. (see photo 26) 1

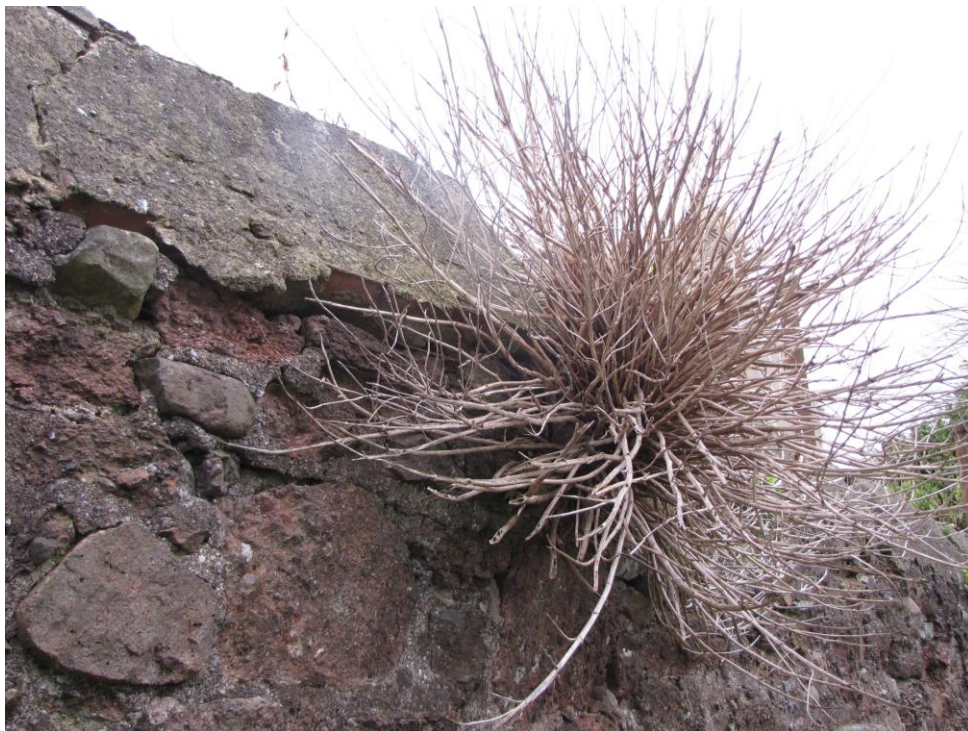
Photo 27

- a) This comprises a high stone wall mostly attached to outbuildings belonging to properties in Daimonds Lane. There is a large valerian growing near the centre which is damaging the masonry and this needs removal and the wall making good. (see photo 27)
