**The Church of St. James,
TEIGNMOUTH, TQ14 9BT**

QUINQUENNIAL REPORT FOLLOWING INSPECTION by R.C. PALMER

NOVEMBER 2019

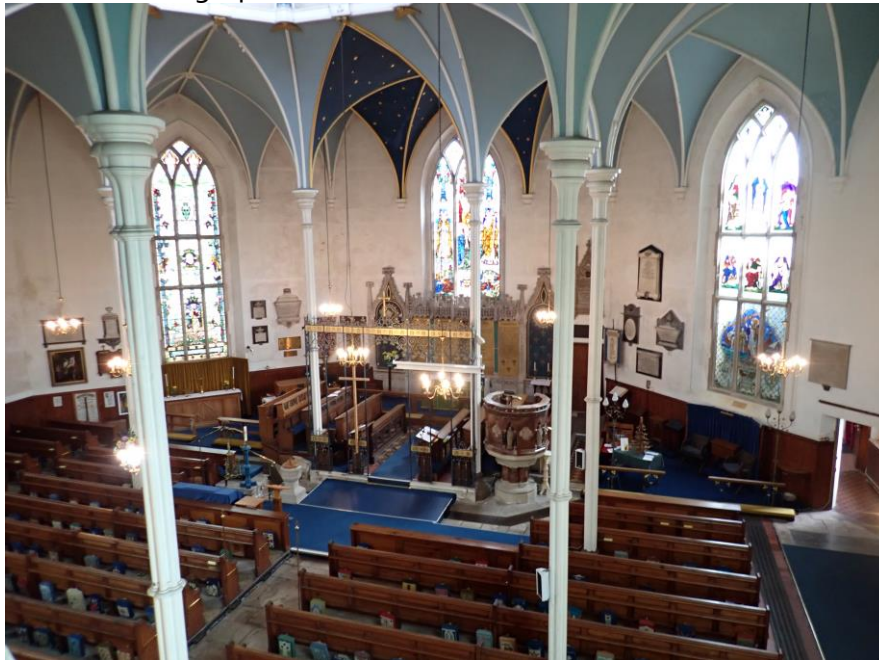
Looking East

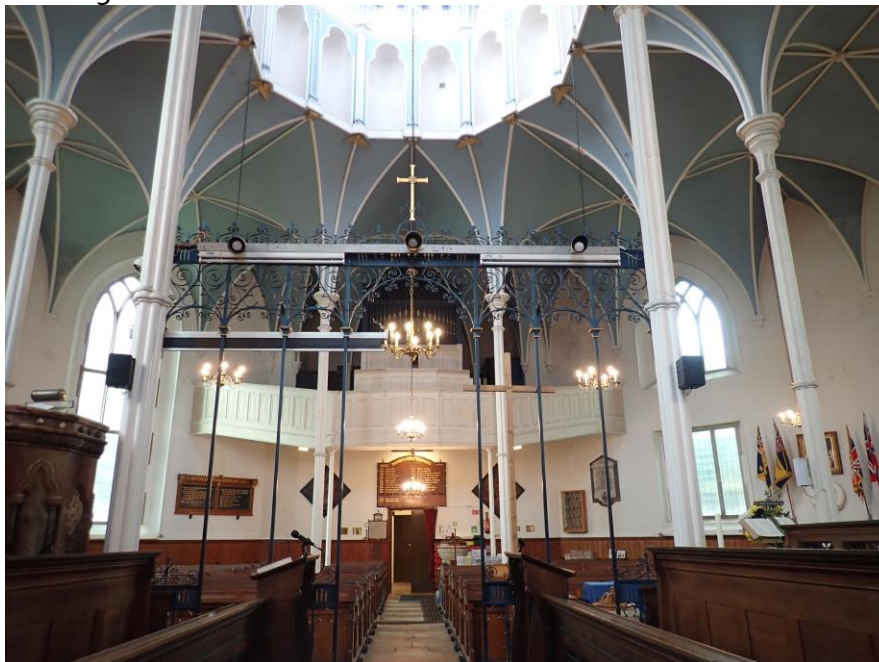
Looking West

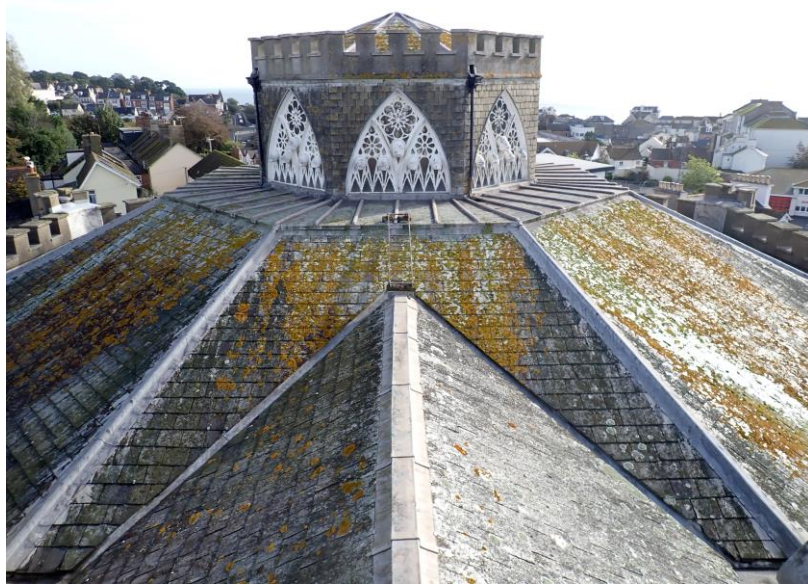
- a) This is pitched with parapet back gutters at the perimeter walls and shallow slate covered slopes away from flat area around the central lantern (see photo overleaf)
- b) The slates are Cornish and mostly in sound condition.
- c) As noted in the previous report the back gutters are covered with lead sheet and the bays are far too long, causing numerous splits to develop. These have been repaired temporarily with flashband and ongoing repairs will be needed regularly until

these gutters are renewed properly with new lead in smaller

bays. I counted 23 separate repairs.

- 3.1 Likely ongoing repairs to back gutters and South Porch roof (B3.2c + 3.4) MW
- 3.2 Repairs to windows W8, 9, 13 and 13A (B9.1c + d and h + i) MW
- 3.3 Redecoration of gates (D29.2)* MW
- 3.4 Repairs to render to turrets (B6.2b and 7.2) MW

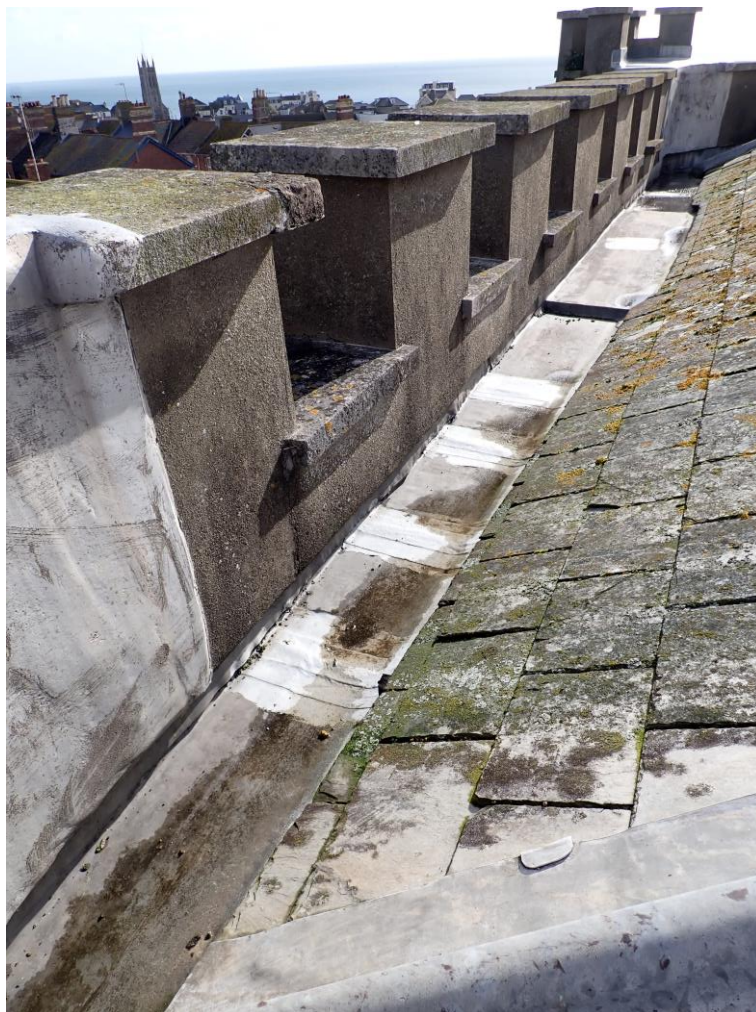
Above: typical bay in back gutter showing temporary repairs

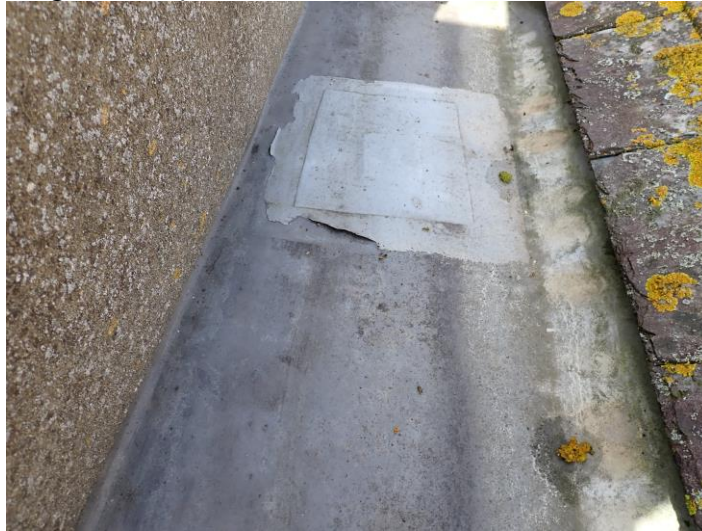
d) One of the flashband repairs has been displaced, possibly by

seagulls (see photo overleaf)

- 1.1 Make good parapet back gutter repair (B3.2d) MW
- 1.2 Replace slates to Whitford room roof (B3.5b+d) MW
- 1.3 Unblock gully (B4.3) MW

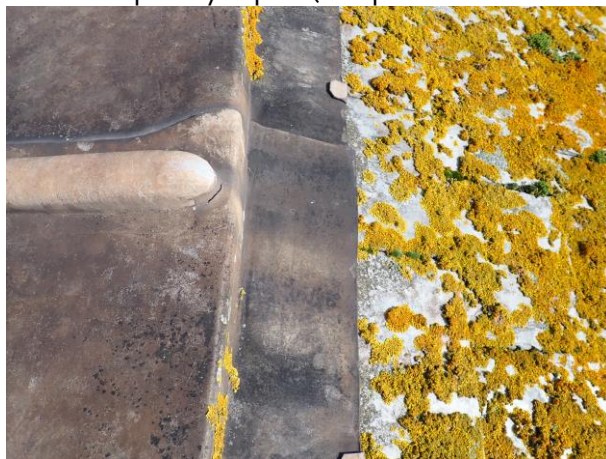
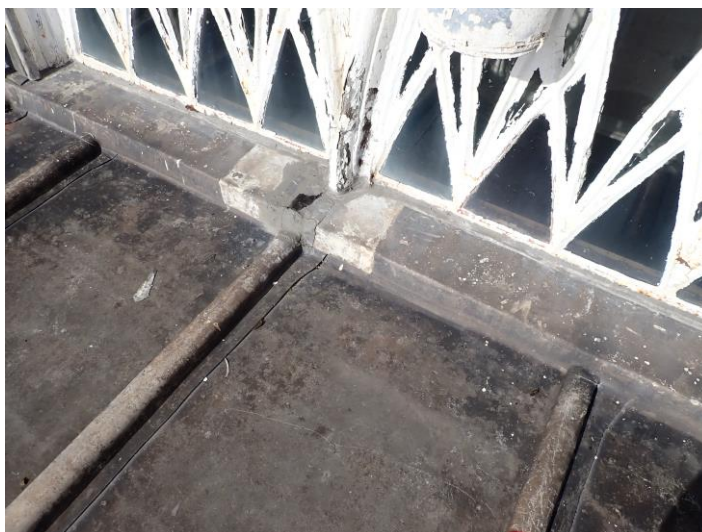
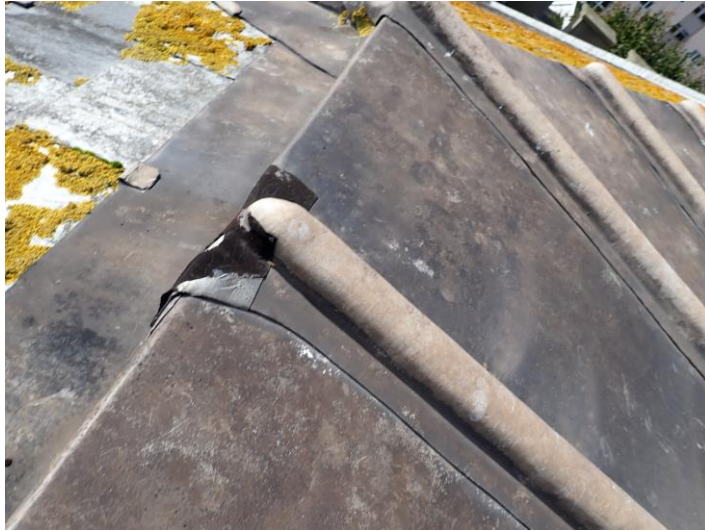
f) The lead rolls are also developing splits at their ends and one has a temporary repair (see photos below and overleaf)

- 2.1 Repair ends of lead rolls (B6.3.2f) MW
- 2.2 Repair and redecorate lantern windows (B9.1j) MW
- 2.3 Repair South Porch rainwater pipe (B4.2c) MW
- 2.4 Repair and redecorate* South Porch doors (B8.1) MW
- 2.5 Inspect lantern roof and main roof space (B3.3b and B12) MW
- 2.6 Repair render (B6.2d and 6.5) MW
- 2.7 Fill cracks (B6.3c) MW
- 2.8 Repair and redecorate steel platform (B8.2) MW
- 2.9 Secure platform in front of choir stalls (B16.1e) MW
- 2.10 Replace broken door knob (B19.1e) MW
- 2.11 Remove ivy (D26.1b+c and 26.2c)* MW
- 2.12 Provide Smartwater (E32)* MW
- 2.13 Improve log book (E34)* MW
- 2.14 Organise asbestos survey (E30.1)* MW

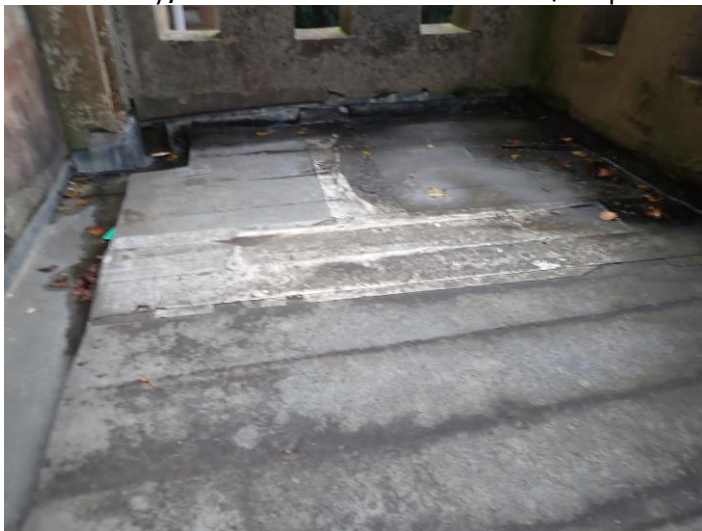
- a) This has a flat roof covered with a large single sheet of lead
- b) It has had numerous temporary repairs, and these will be ongoing until the covering is replaced in smaller bays of lead or, due to its vulnerability, terne coated stainless steel (see photo below)

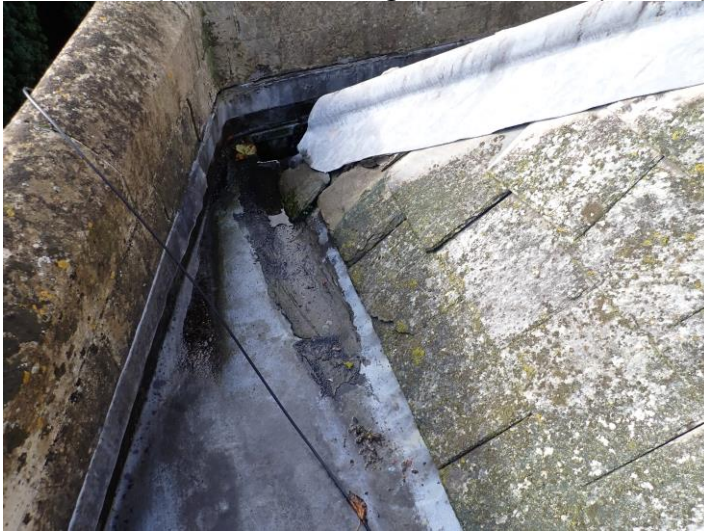
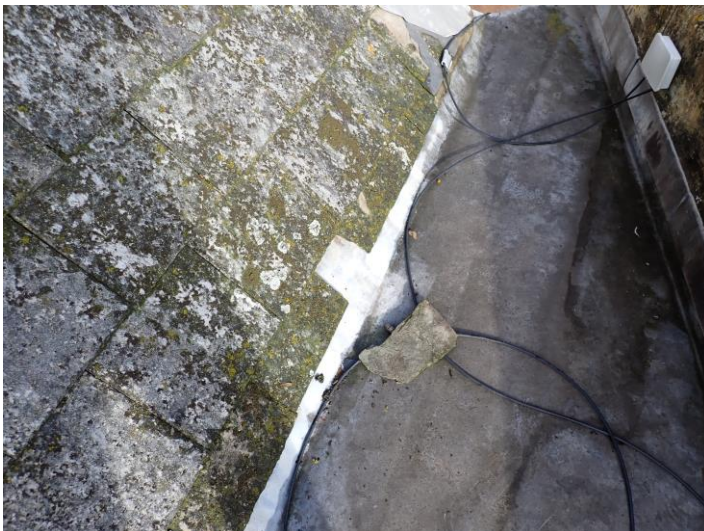
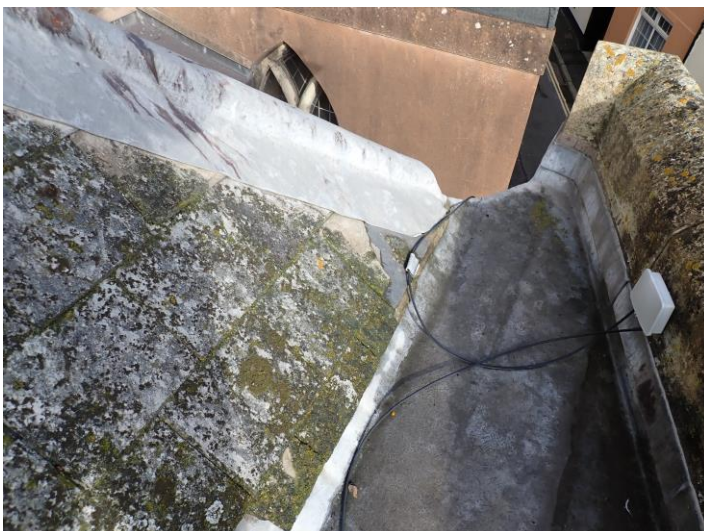
b) There are 3 part slates missing on the east slope (see photos below)

c) The lead back gutter has a bitumen repair (see first photo above)

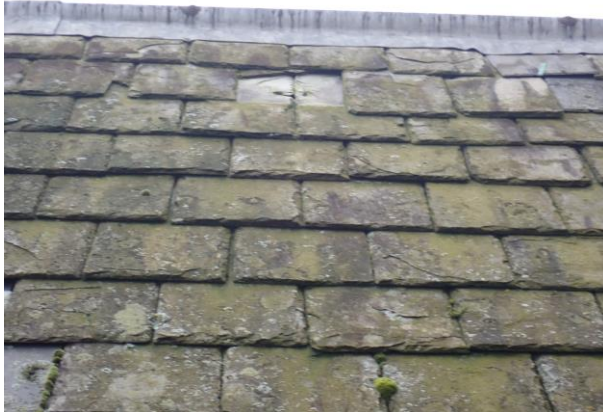
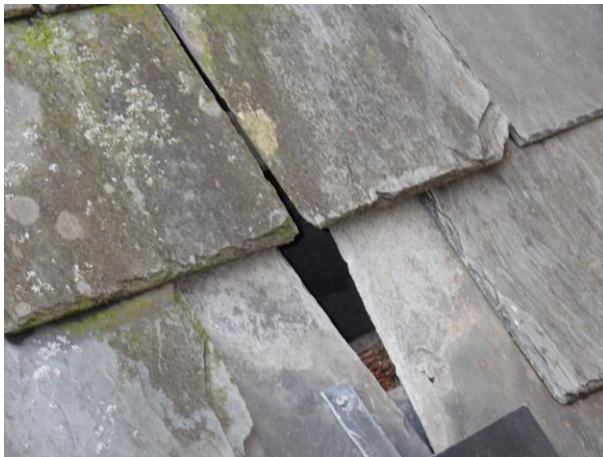
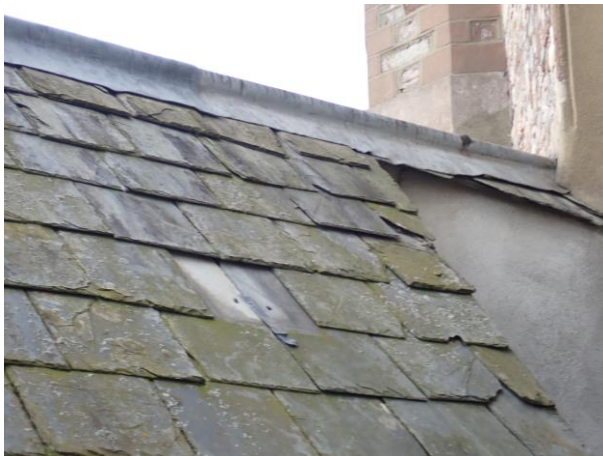
d) The north slope is in poor condition, with several slates missing, and with the roofspace open to the elements in one location (see photos

below)

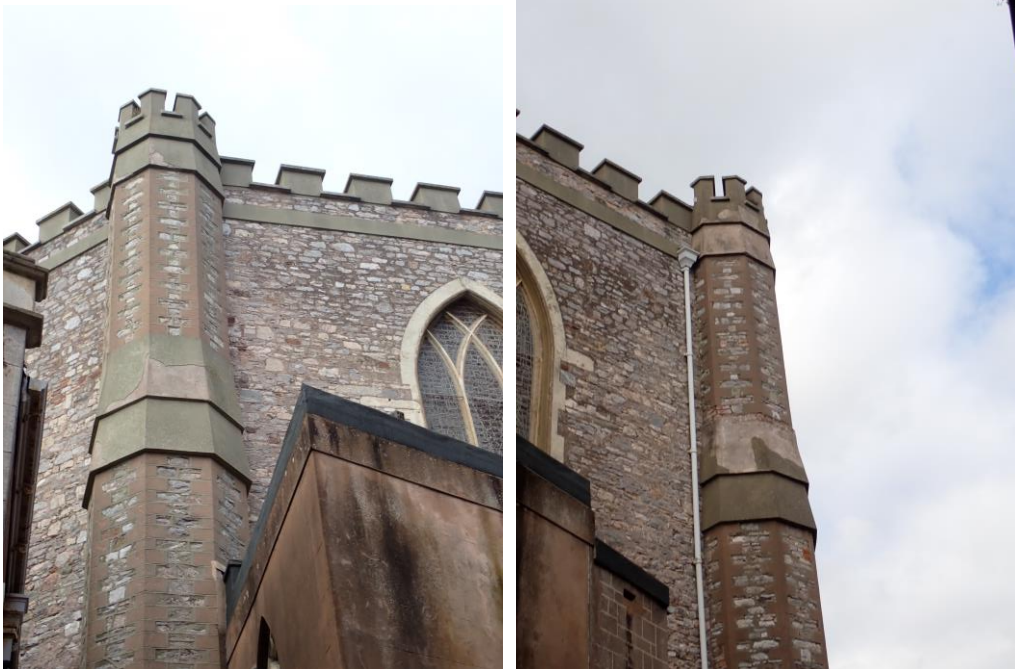
- a) These have embattled parapets that are rendered internally and externally with a hard cement render, causing any moisture that penetrates to be trapped. D
- b) On the east elevation the top coat of render has failed (see photos below) 2

7.2 Dressings to the corner turrets are rendered and this is defective on the east elevation (see photos on previous page)

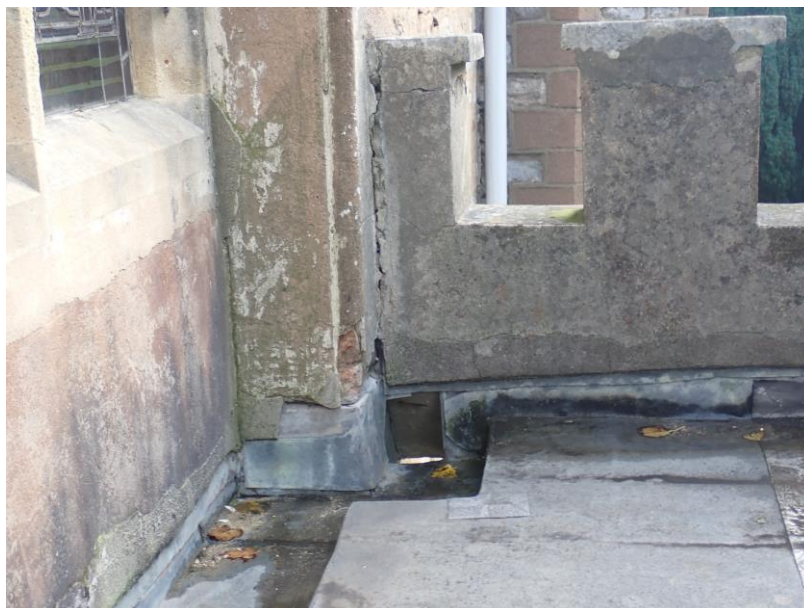
- c) In some areas the internal render has been covered with bitumen, further sealing in any dampness D
- d) A rendered section above the South Porch roof needs attention (see photo overleaf) 1

The parapet walls are rendered and these need attention where they meet the main walls (see photo above)

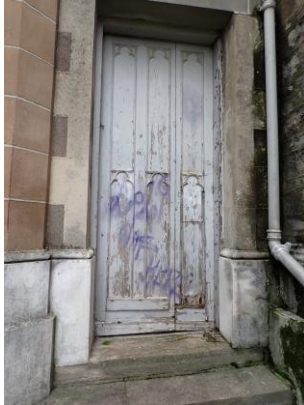
East door of South Porch

8.1 The South Porch doors are in poor condition with repairs and redecoration needed. There is graffiti on one of the doors (see photo overleaf)

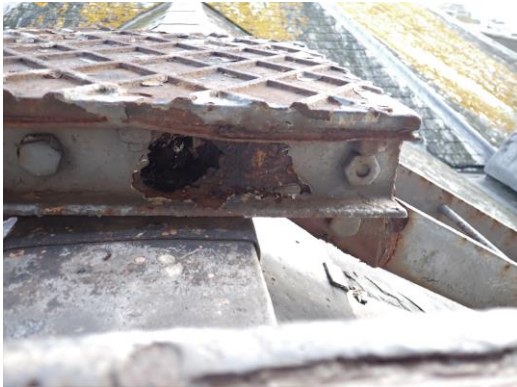
Main roof access platform

8.2 The steel platform at the top of the permanent roof access ladders is rusting badly and needs attention (see photo overleaf)

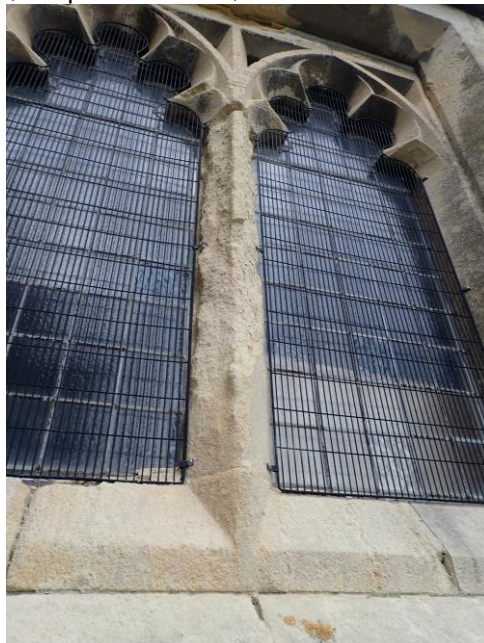
- a) W1 & W3-W7: satisfactory
- b) W2: Some masonry erosion
- c) W8: Mullion heavily eroded to glass line and erosion to head (see photo below)

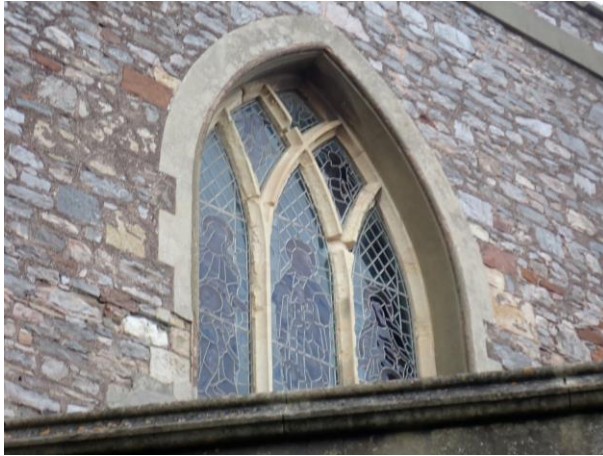
- d) W9: Tracery erosion leaving gaps at junctions with glazing (see photo below)

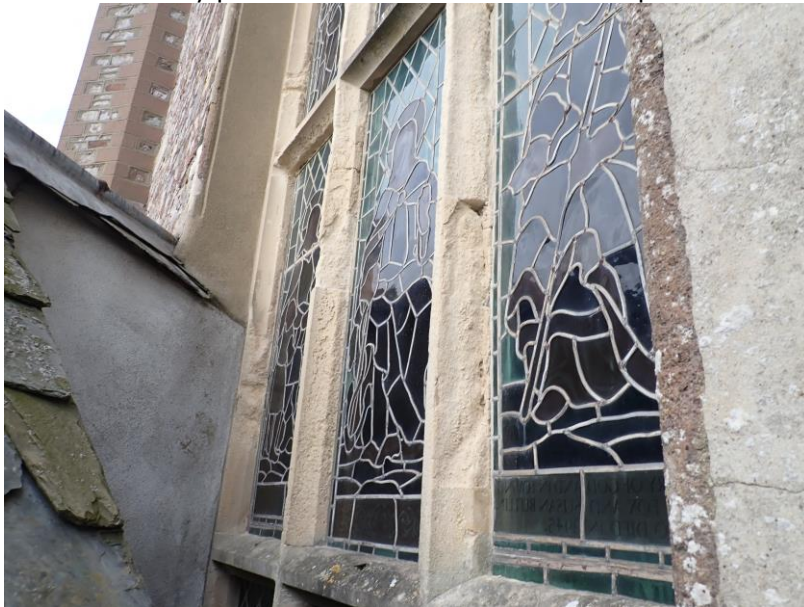
Mullions in very poor condition lower down (see photo below)

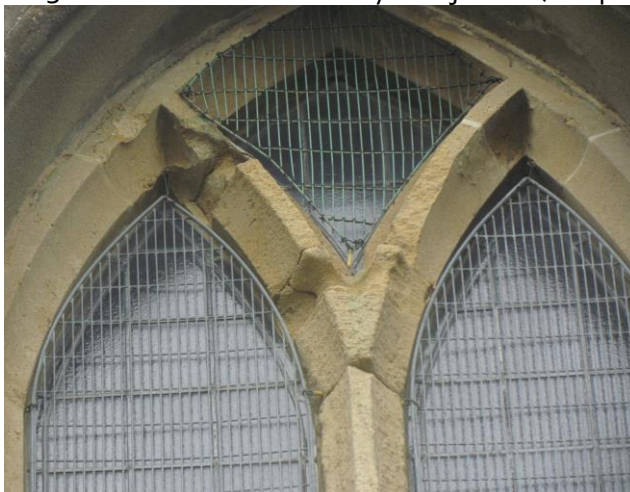
- e) W10: Minor erosion to masonry
f) W11: Tracery erosion
g) W12: Erosion to mullions
h) W13: Much erosion to tracery and jambs (see photo below)

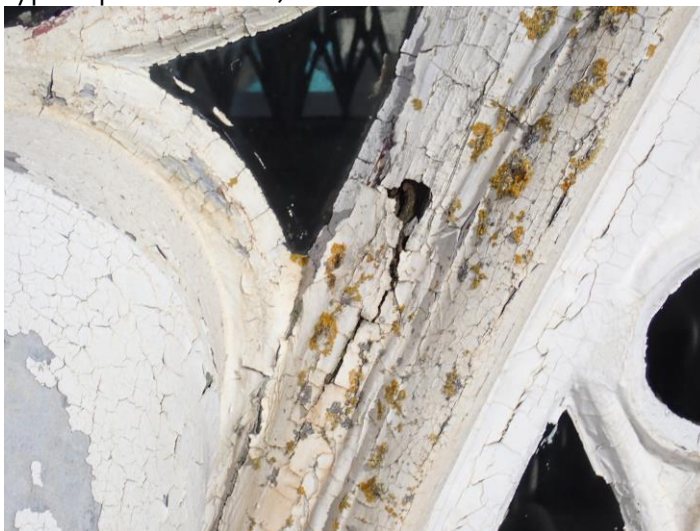
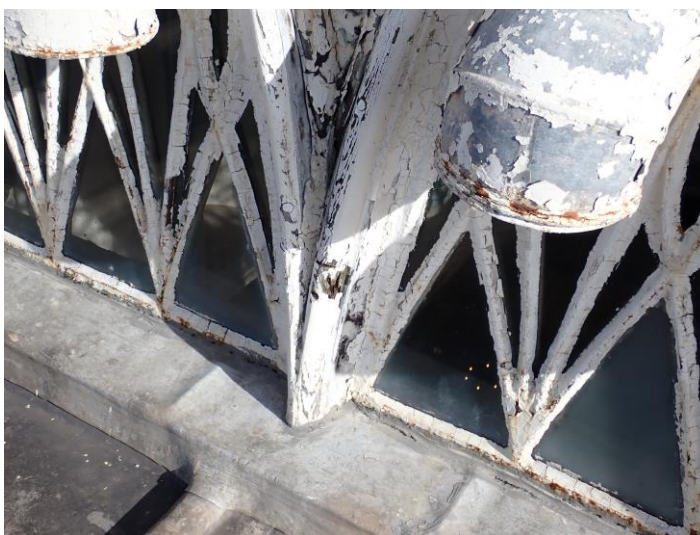
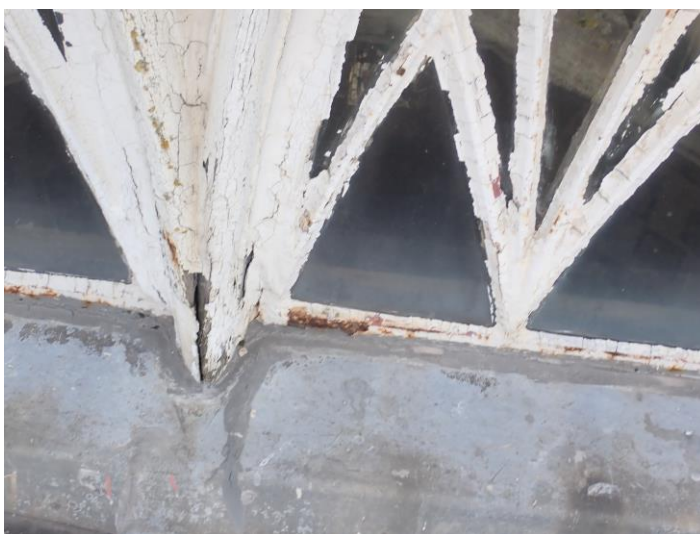
- i) W13A: Timber window needs repair to beads and redecoration 2
- j) Lantern windows: Many repairs and redecoration needed (see typical photos below) 1

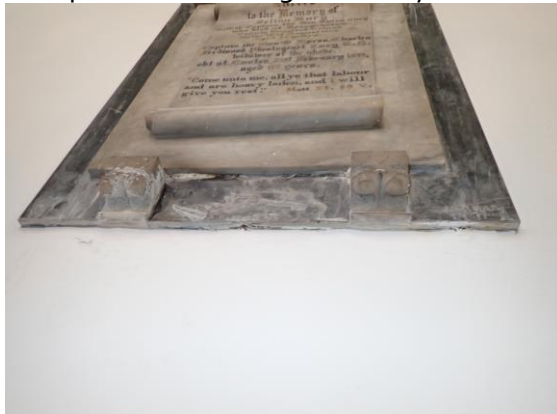
- 21.1 The Lucy Townshend memorial on the south wall has been removed since the last inspection for safety reasons.
- 21.2 Dampness is affecting the Carey monument (see photo below) D

- 5.17 Replacement of dado boarding and supports (B17.4) E
- 5.18 Reredos conservation (D18.2) D/E
- 5.19 Conservation of monument (B21.2) E
- 5.20 Repairs to tomb (D25.3) E
