**The Church of St. James,
TEIGNMOUTH, TQ14 9BT**

QUINQUENNIAL REPORT FOLLOWING INSPECTION by R.C. PALMER

JULY 2014

Report on the condition of the building following Quinquennial Inspection by R.C. Palmer, Dip.Arch, Pg. Dip., M.A., A.A.B.C.

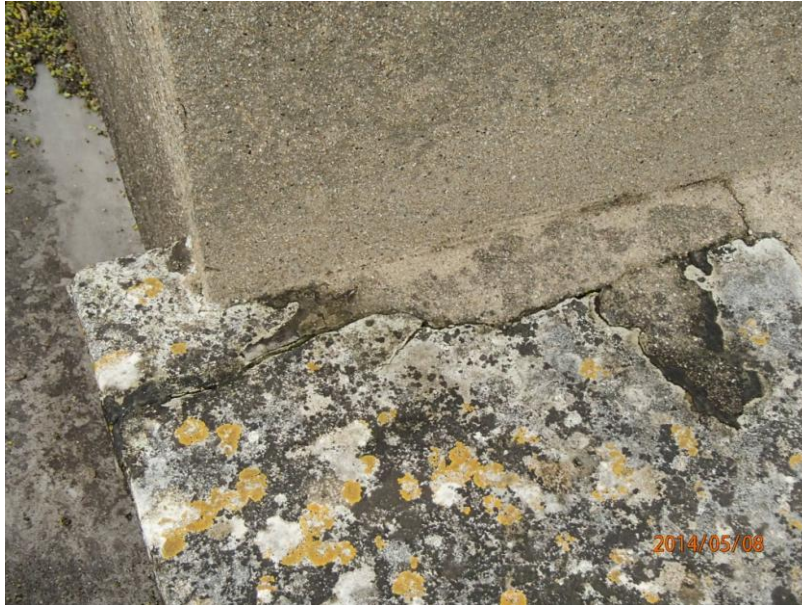
- a) These have embattled parapets that are rendered internally and externally with a hard cement render, causing any moisture that penetrates to be trapped. D
- b) In some areas the render has been covered with bitumen, further sealing in any dampness D
- c) The coping of one of the embrasures to the south elevation has cracks that need filling (see photo overleaf) 1

- 2.1 Fill/repair cracks (B6.2c + 6.3c) **MW**
- 2.2 Repair and redecorate lantern windows (B9.1i) **MW**
- 2.3 Check stability of wall plaque (B21)* **MW**
- 2.4 Decorate Porch doors (B8.1)* **MW**
- 2.5 Repair plinths (B7.3 + 29.2) **MW**
- 2.6 Repair and redecorate steel platform (B8.2) **MW**
- 2.7 Remove ivy and fill holes (D26.1b+c) **MW**
- 2.8 Provide Smartwater (E32)* **MW**
- 2.9 Improve log book (E34)* **MW**
- 2.10 Organise asbestos survey (E30.1)* **MW**

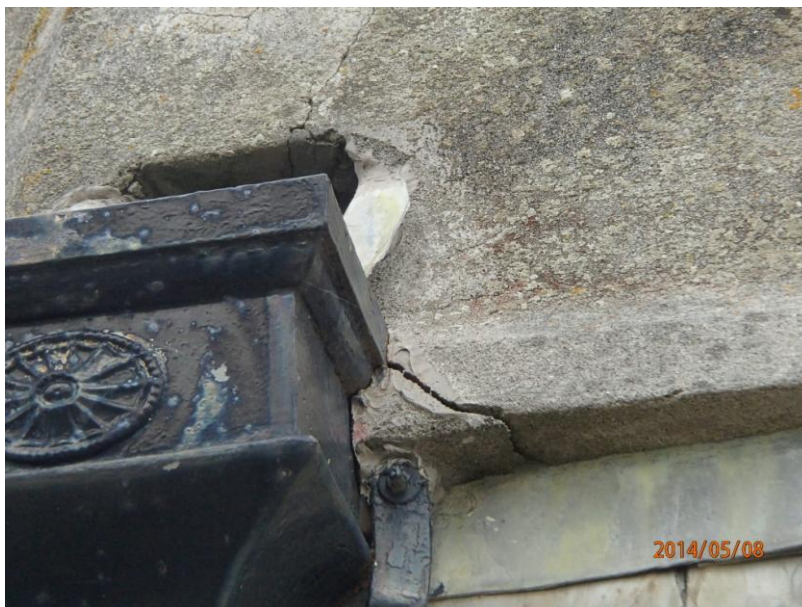
- a) This also has embattled rendered walls with the same problems. D
- b) Some of the copings have made up in 4 pieces; ideally these should be replaced with single stones. D
- c) There are cracks by the south west hopper that should be filled (see photo) 1

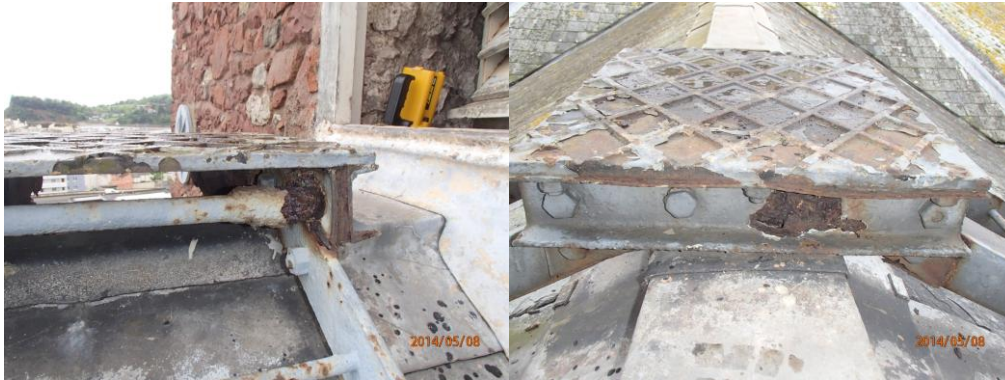
- 8.1 The decorations to the Porch doors are very poor. 1
- 8.2 The steel platform at the top of the permanent roof access ladders is rusting badly and needs attention (see photos below) 1

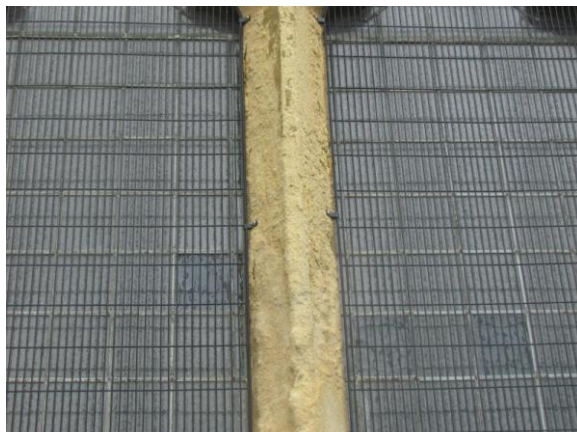
- a) W1: 3 - 7,11, 14 - 16 satisfactory
- b) W2: Some masonry erosion E
- c) W8: Mullion eroding (see photo below) 5

- 4.1 Redecorate rainwater goods (B4.2b) MW
- 4.2 Window W8, 9 + 12 repairs (B9.1c, d + f) MW
- 4.3 Renewal of lead to parapet back gutters and Porch roof (B3.2c + 3.4b)
- 4.4 Electrical test and report (C22.3) MW
- 4.5 Continue to check inspection chamber and vestry floor (B5.2b + 19.1d)* MW
- 4.6 Possible dado repairs (B17.4) MW
- 4.7 Fill gaps in boundary wall copings (26.2a) MW

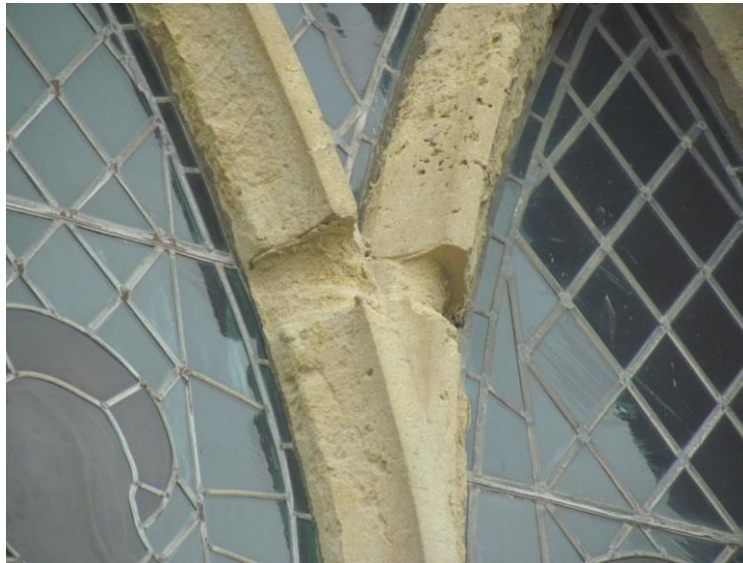
d) W9: Tracery erosion (see photo below)

5

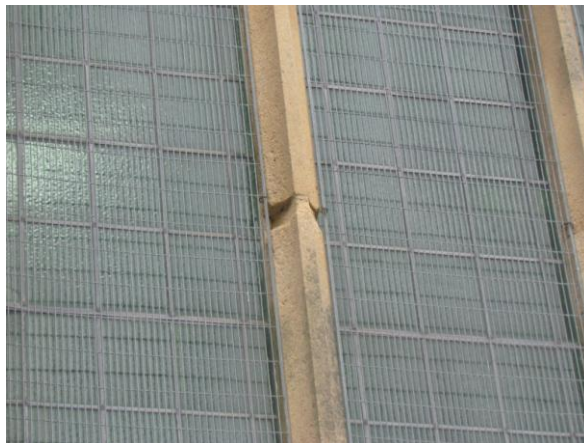
f) W12: Erosion to mullion (see photo below)

5

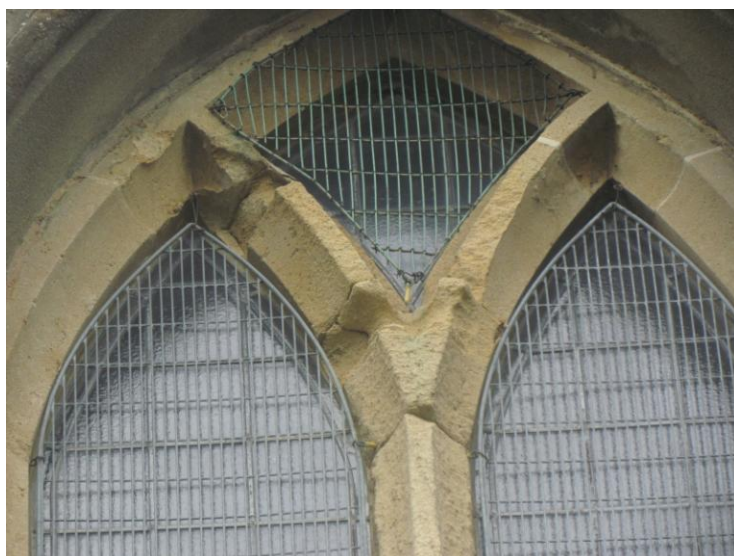
g) W13: Much erosion to tracery and jambs (see photo below)

2

- 3.1 Repairs to window W13 masonry (B9.1g) **MW**
- 3.2 Repairs and redecorations to window W13A (B9.1h) **MW**

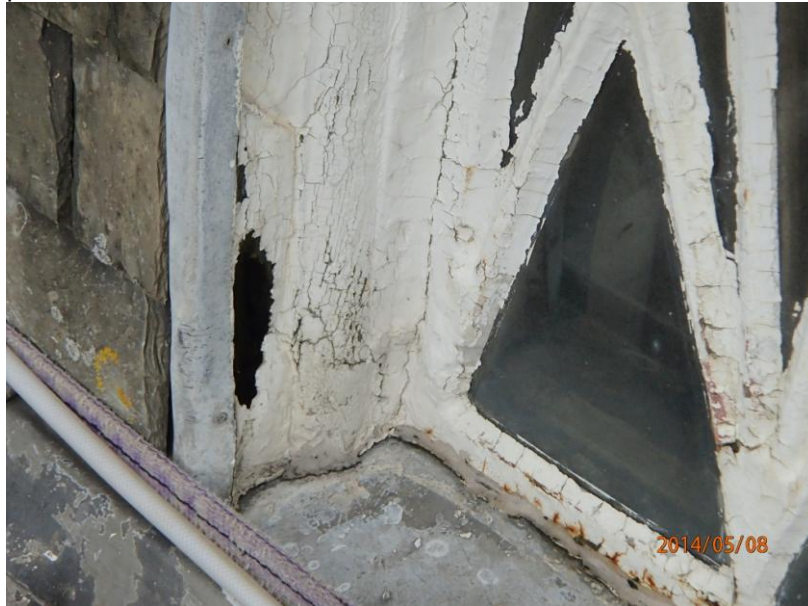
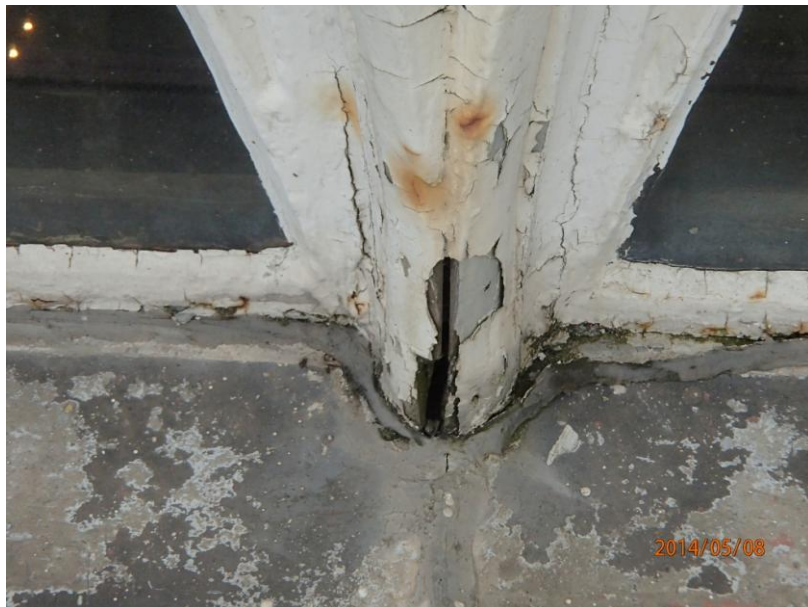
- h) W13A: Timber window needs repair to beads and redecoration 2
- i) Lantern windows: Many repairs and redecoration needed (see photos below) 1

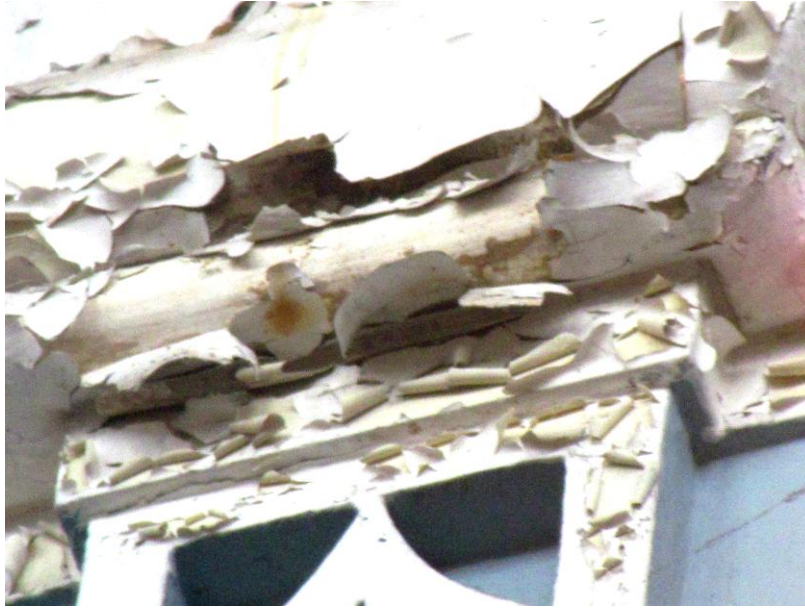
- a) The cills of the lantern windows are flaking where they are affected by the defects shown above (see photo overleaf) D
- b) Iron saddle bars are starting to cause damage to the internal masonry of W1, W9, W12 and W15 D/E

- 5.9 Redecoration of lantern windows internally after repair (B9.2a) D
- 5.10 Replacement of saddle bars in phosphor bronze and making good of masonry (B9.2b) D/E

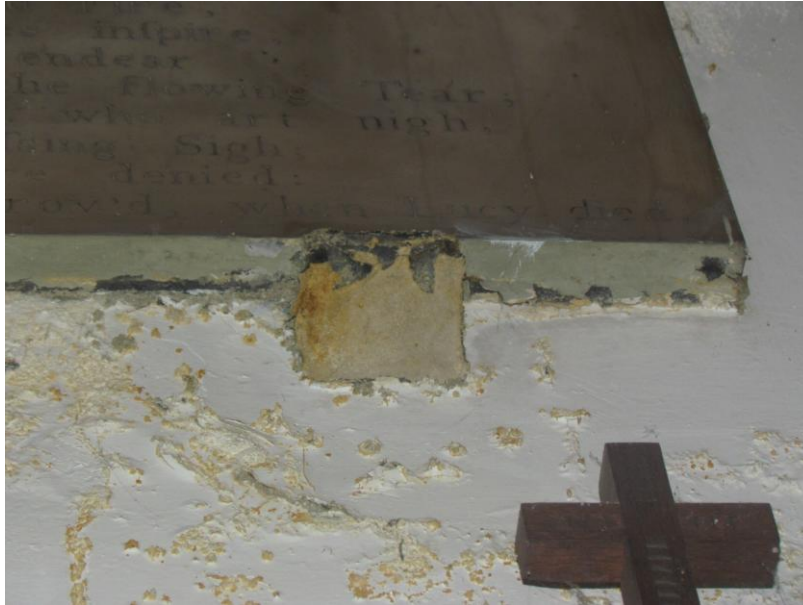
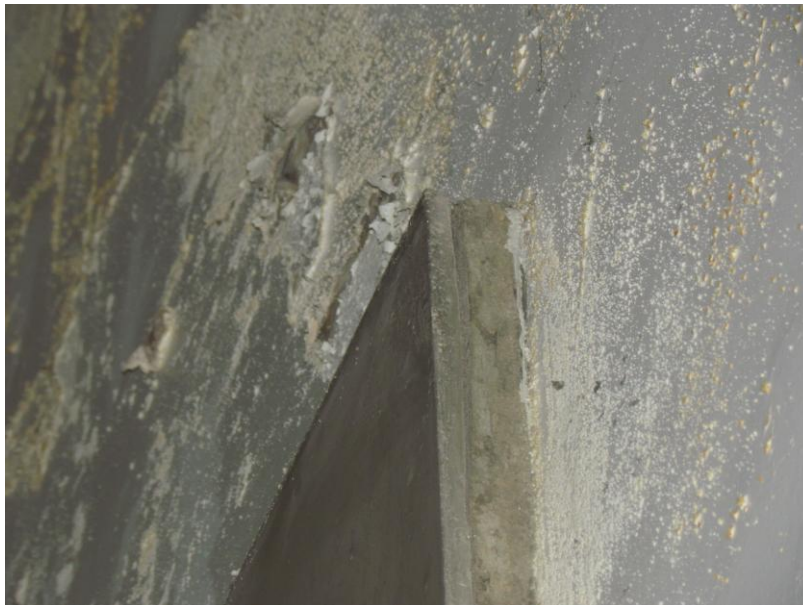
The Lucy Townshend memorial on the south wall is being damaged by the damp. A corbel is eroding and the face of the plaque appears to be falling away. See photos overleaf. 1/D
