**ST JAME'S CHURCH
TEIGNMOUTH, DEVON**

QUINQUENNIAL INSPECTION REPORT

Inspector: Mr Grant Elliott, RIBA, CA

Date of Inspection: 9th November 2022

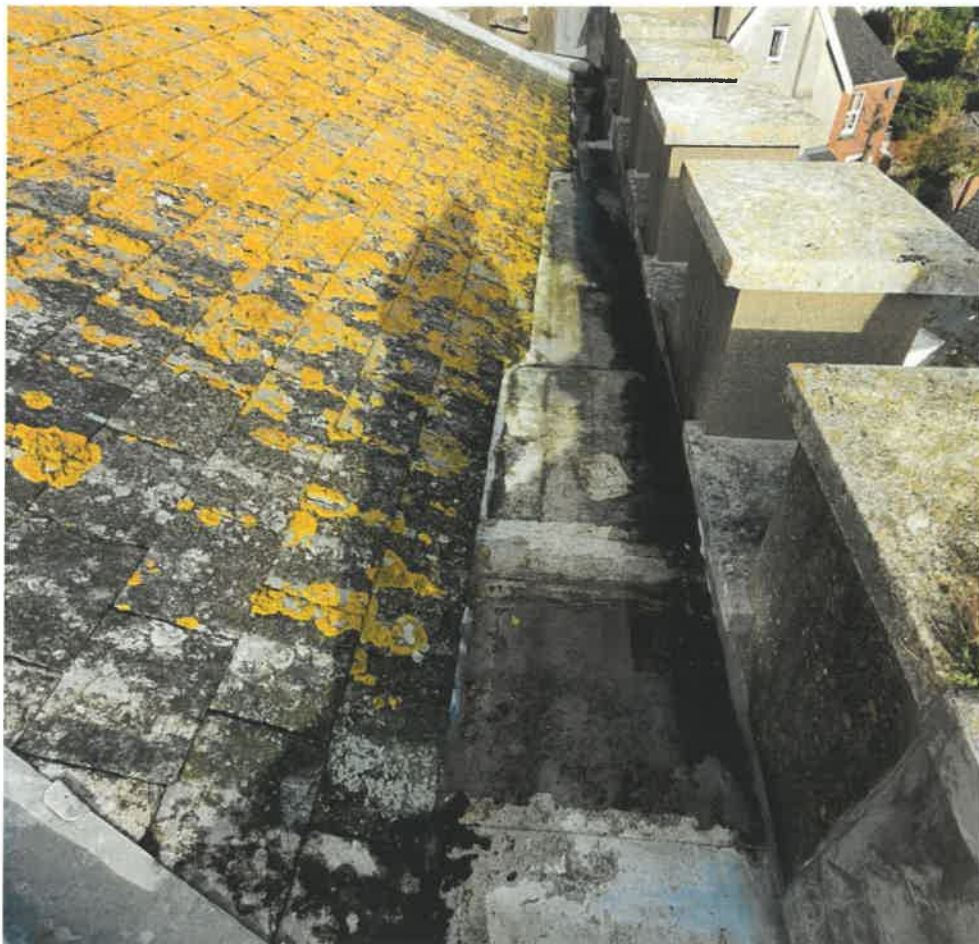
As noted in the previous report, the back gutters are covered with lead sheet and the bays are far too long, causing numerous splits to develop. These have been repaired temporarily with flashband and ongoing repairs will be needed regularly until these gutters are renewed properly with new lead in smaller bays. **C**

06 Overlong Valley Gutter with Flashband Repairs

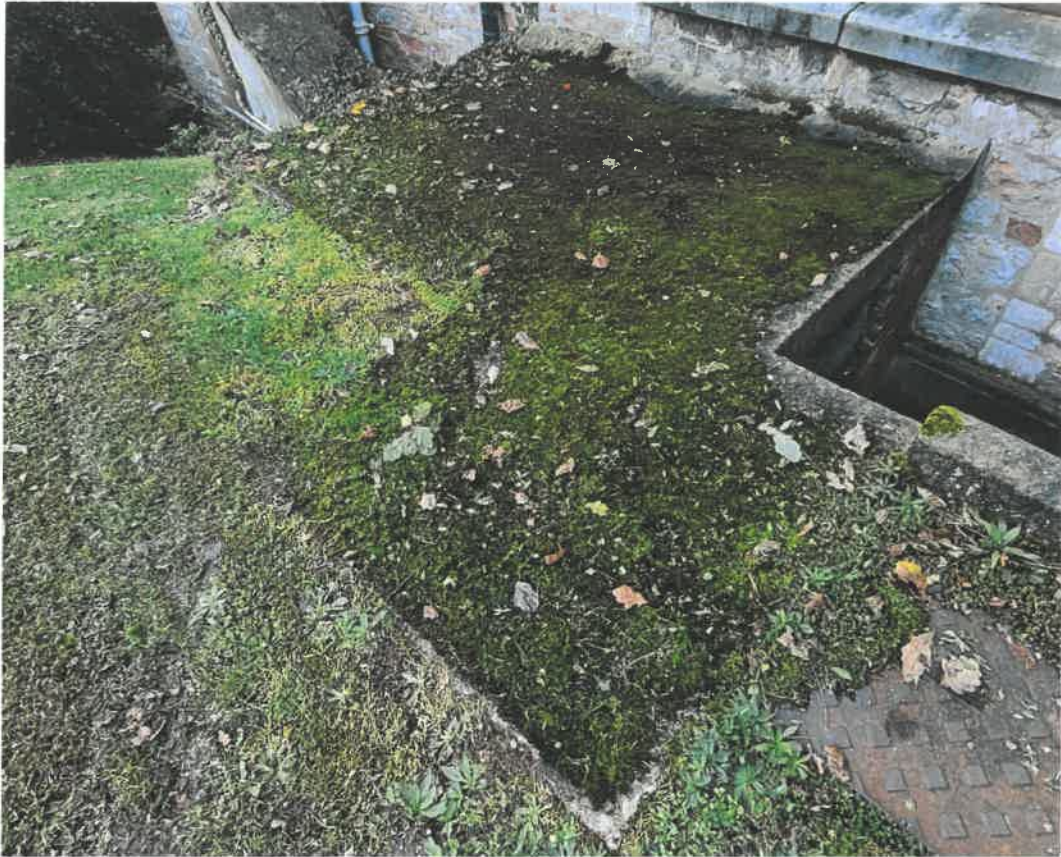
13 Boiler Room Roof

This has a flat roof covered with a large single sheet of lead. The previous Church Architect noted it has had numerous temporary repairs, and these would be ongoing until the covering is replaced in smaller bays of lead or, due to its vulnerability, terne coated stainless steel.

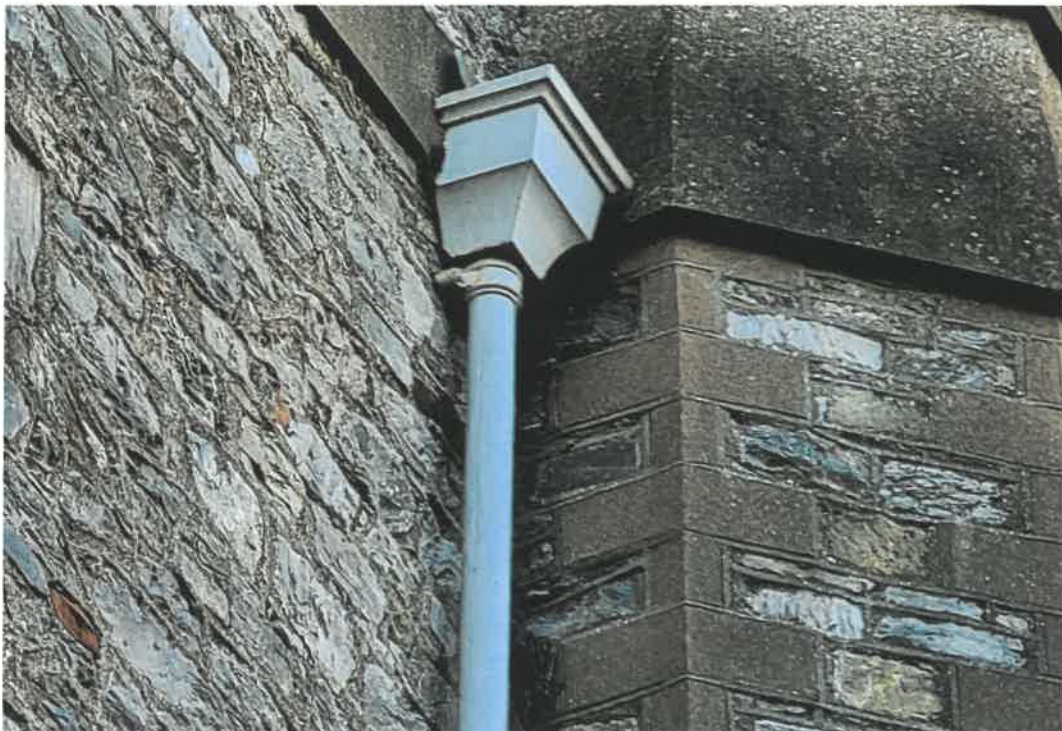
14 Hopper in Reasonable Condition

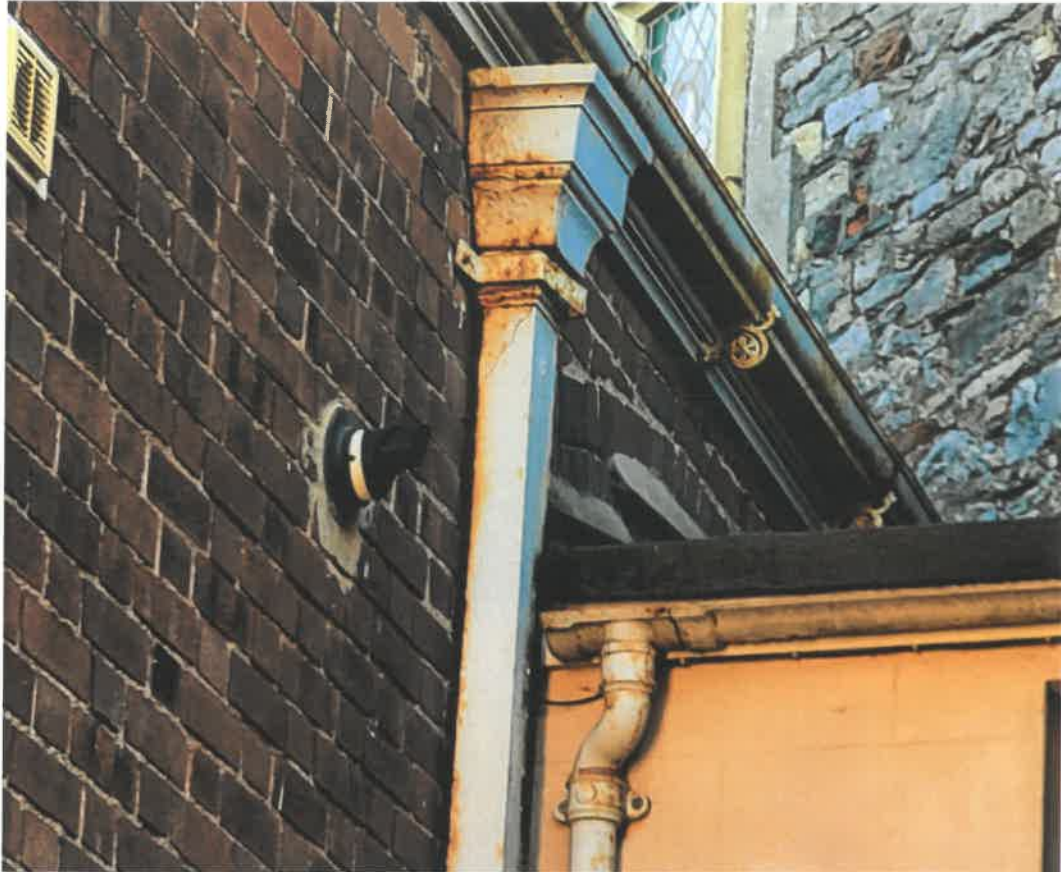
15 Rainwater Goods in need of Derusting and Decoration

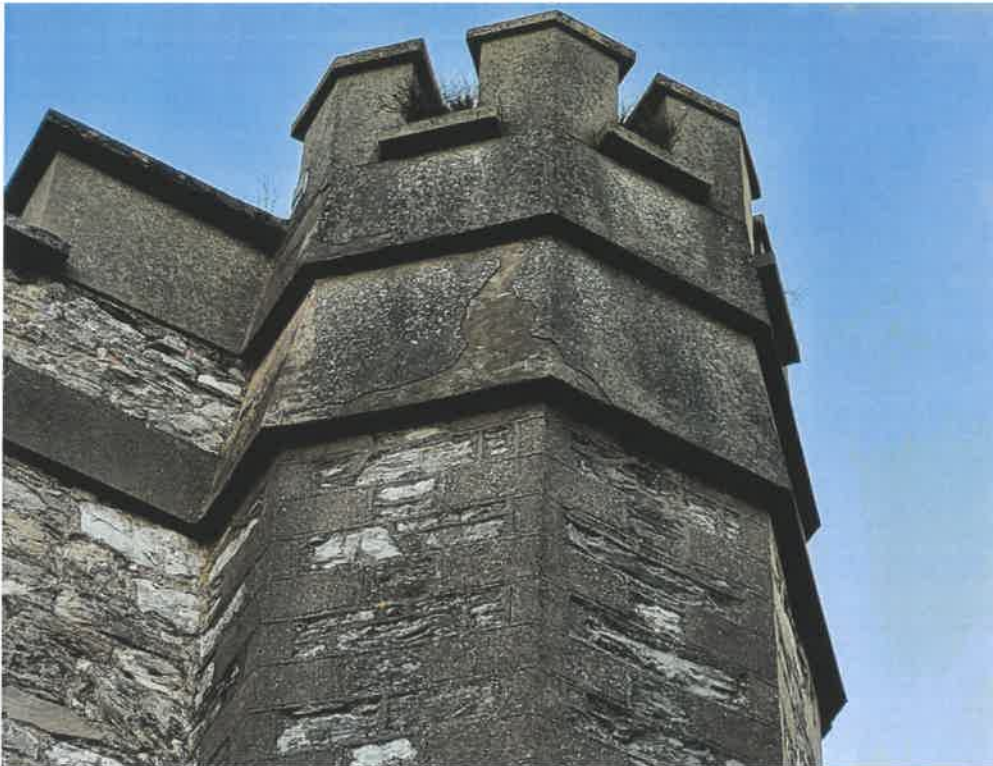
20 Render Failing to Corner Turret

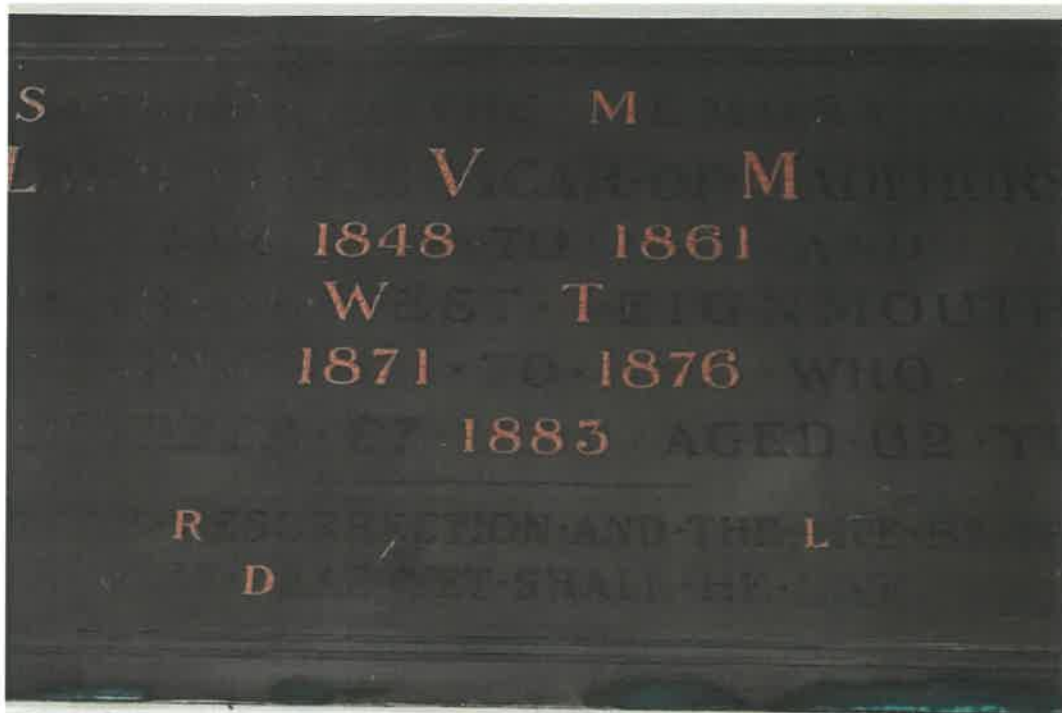
92 Monument where Lettering needs Repainting
