**ST JAME'S CHURCH
TEIGNMOUTH, DEVON**

QUINQUENNIAL INSPECTION REPORT

Inspector: Mr Grant Elliott, RIBA, CA

Date of Inspection: 9th November 2022

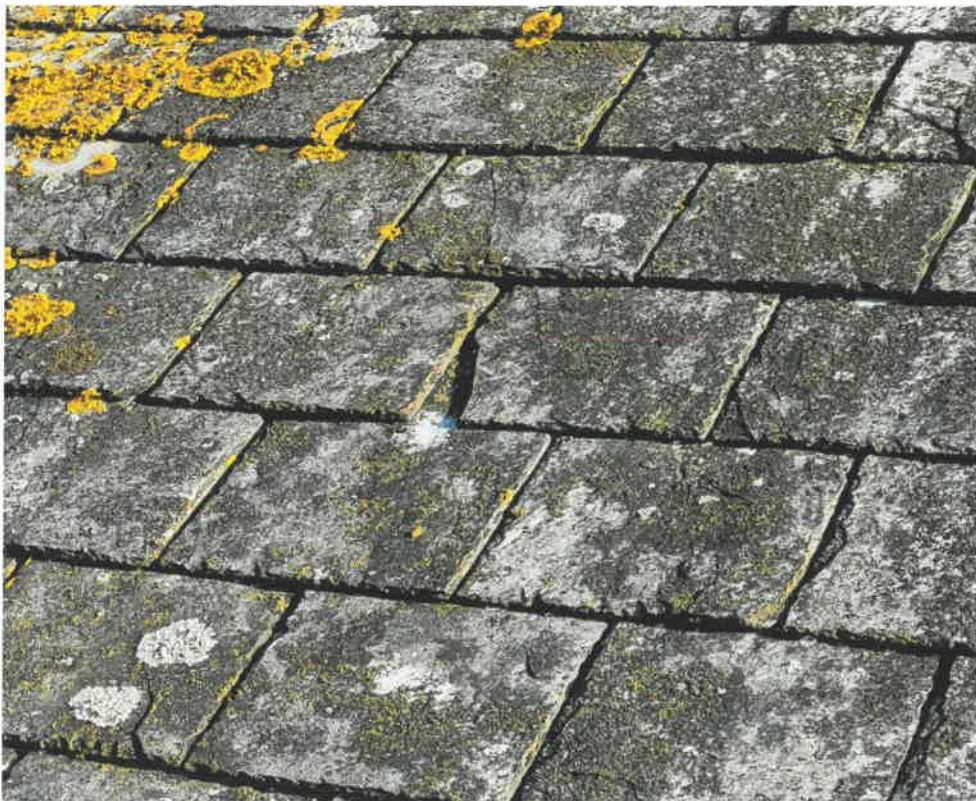
The slates are Cornish and mostly in sound condition. There are a few broken slates that need attending to. The moss should be cleared from the slates. **B**

04 Broken Slates

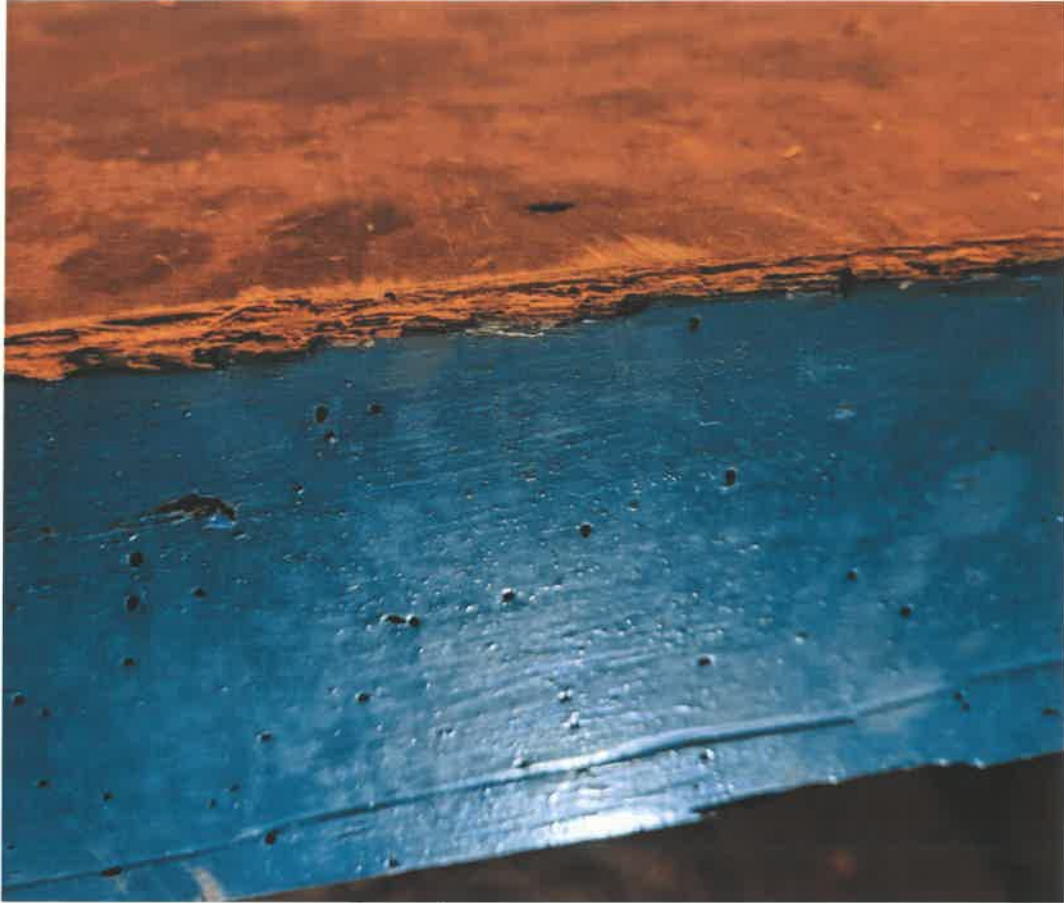
59 Woodworm to Clock Casing

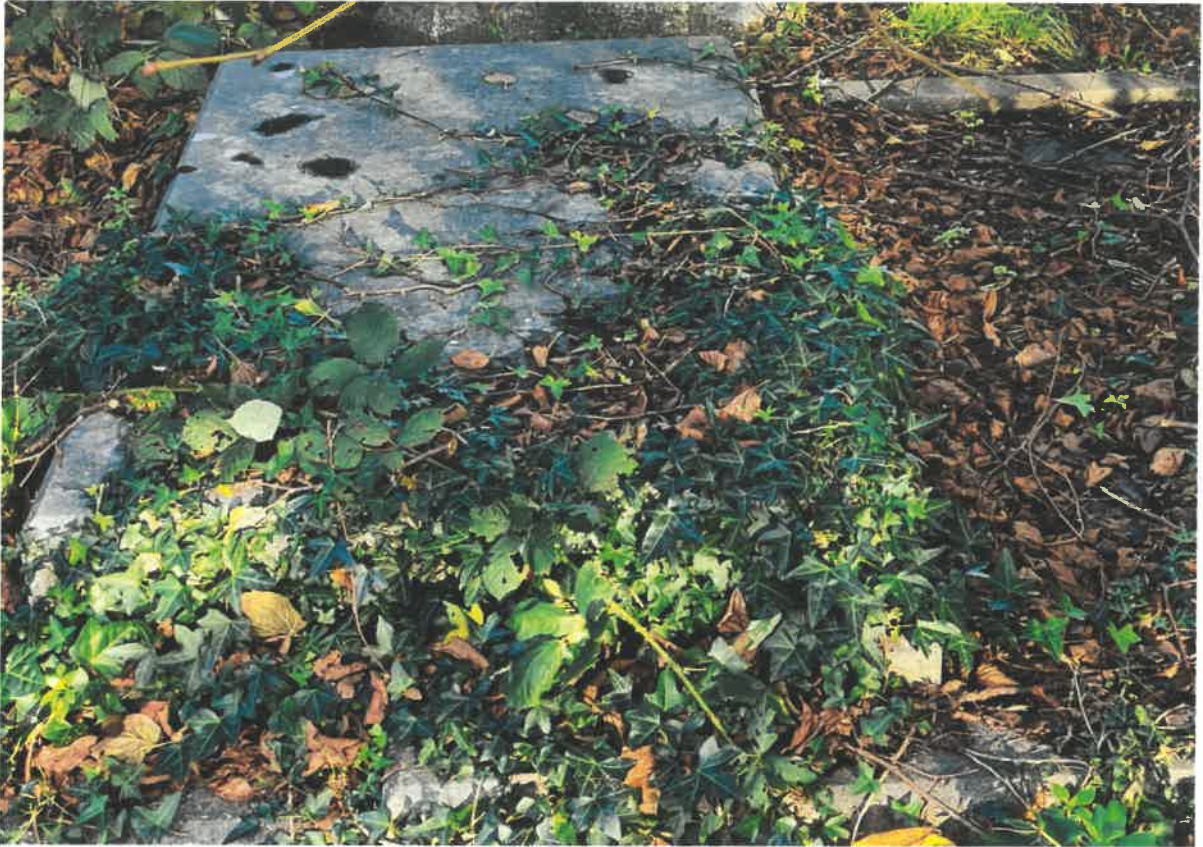
101 Ivy on Monument

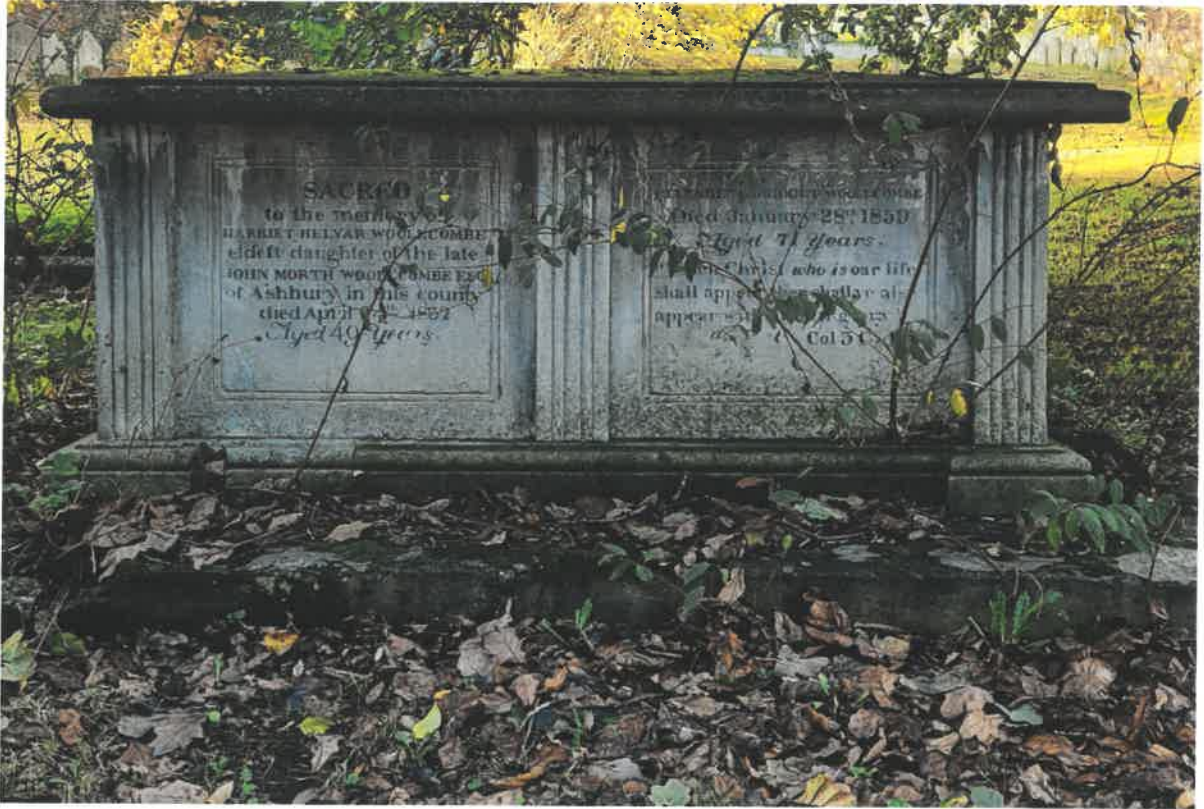
103 Woollcombe Tomb

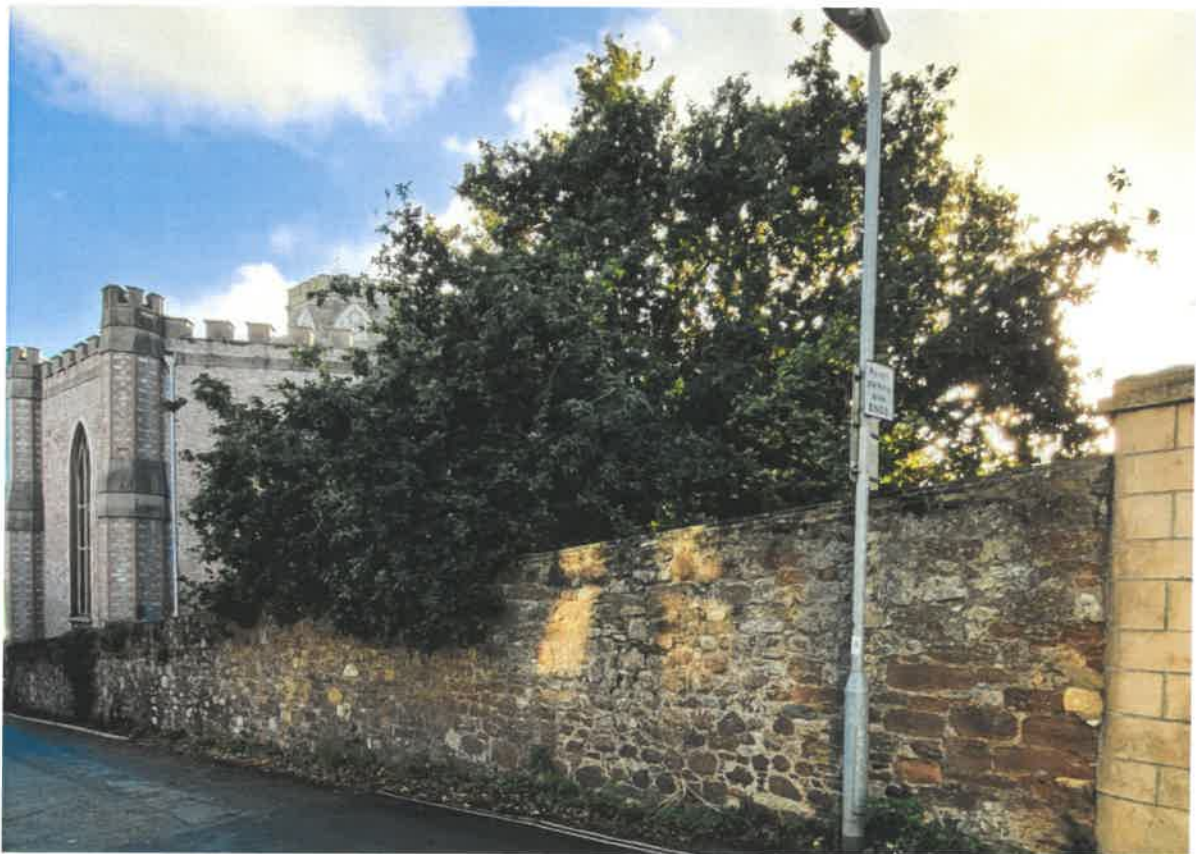
104 Oak Tree

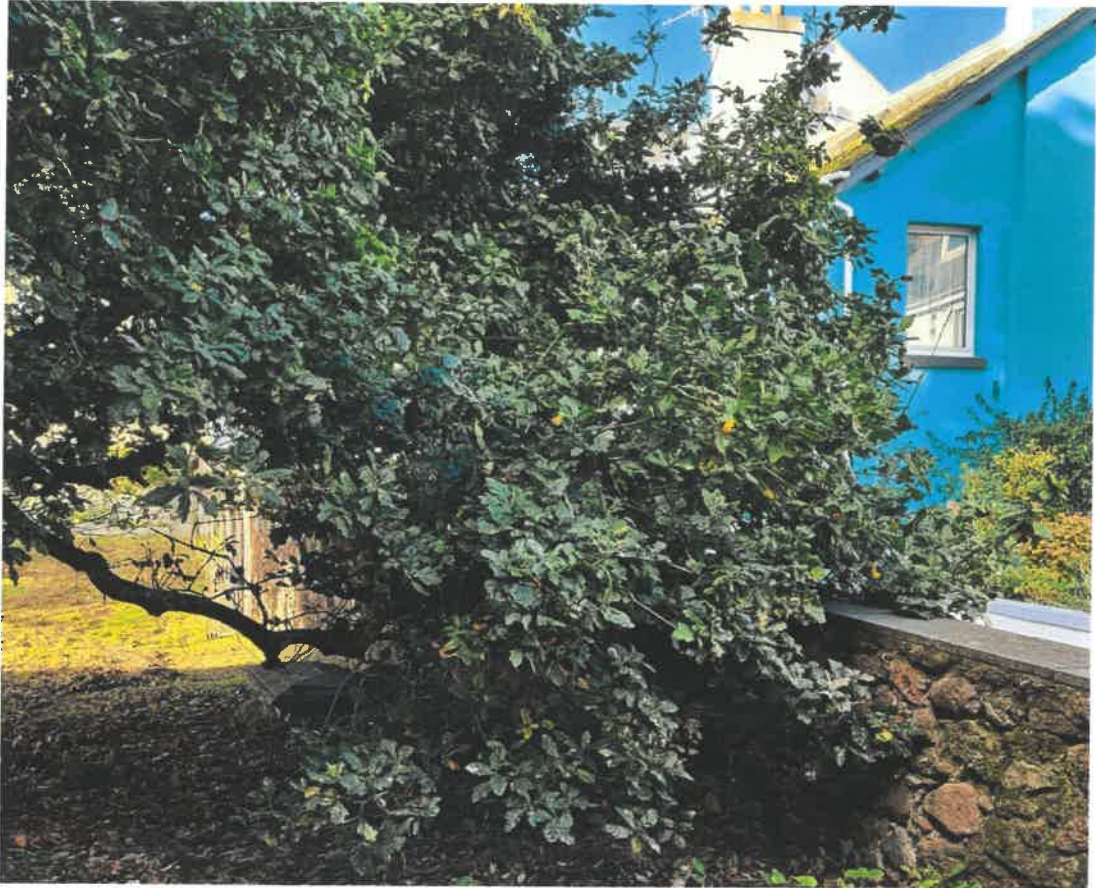
105 Oak Tree

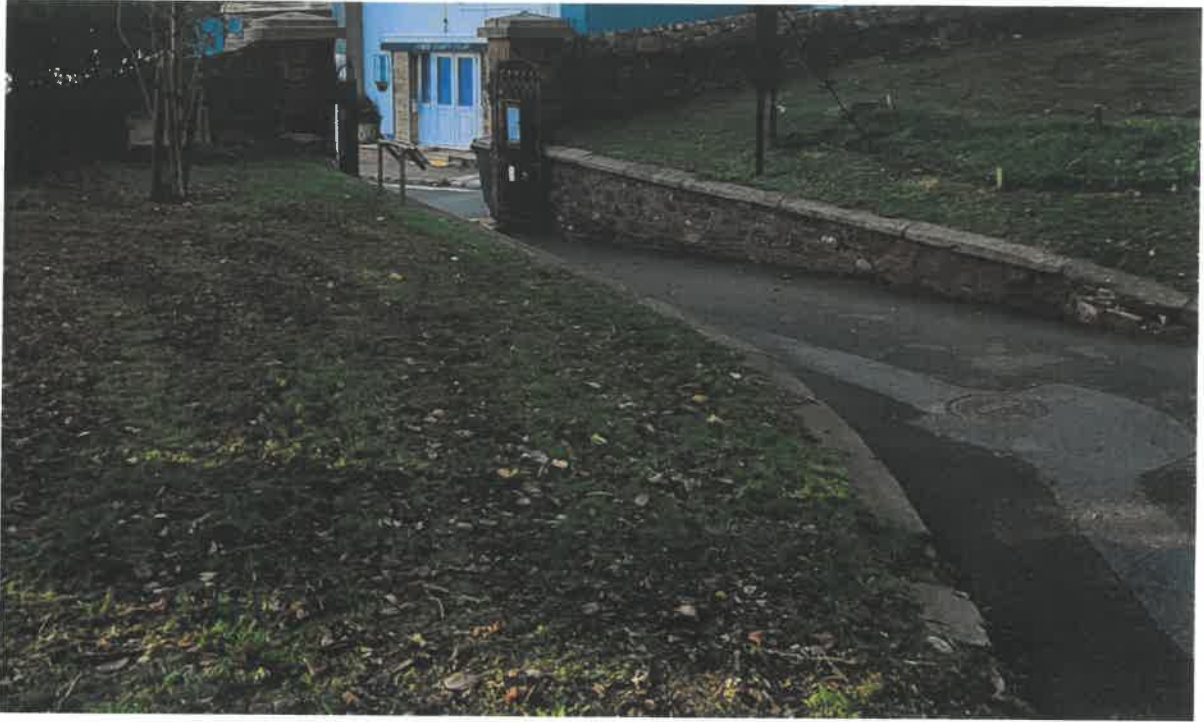
107 Tarmac Path

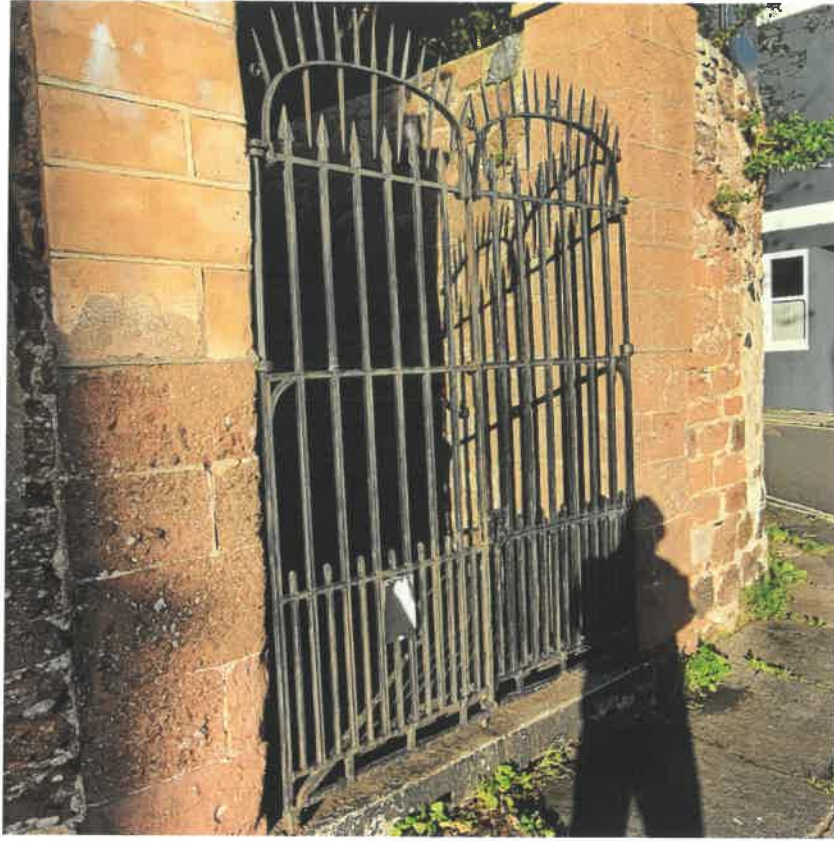
109 South Gates

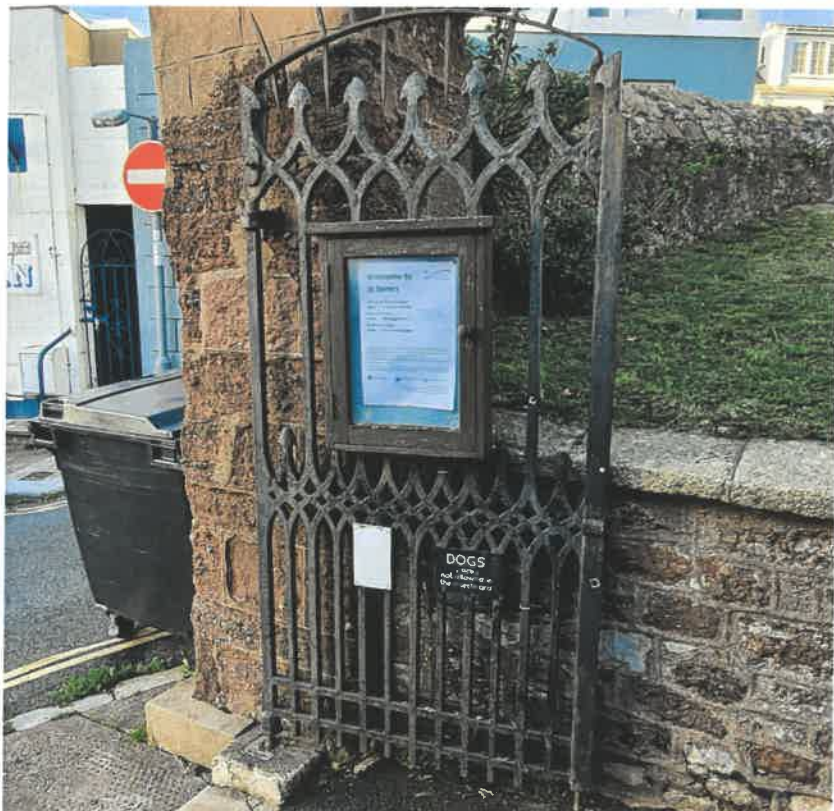
110 West Gates

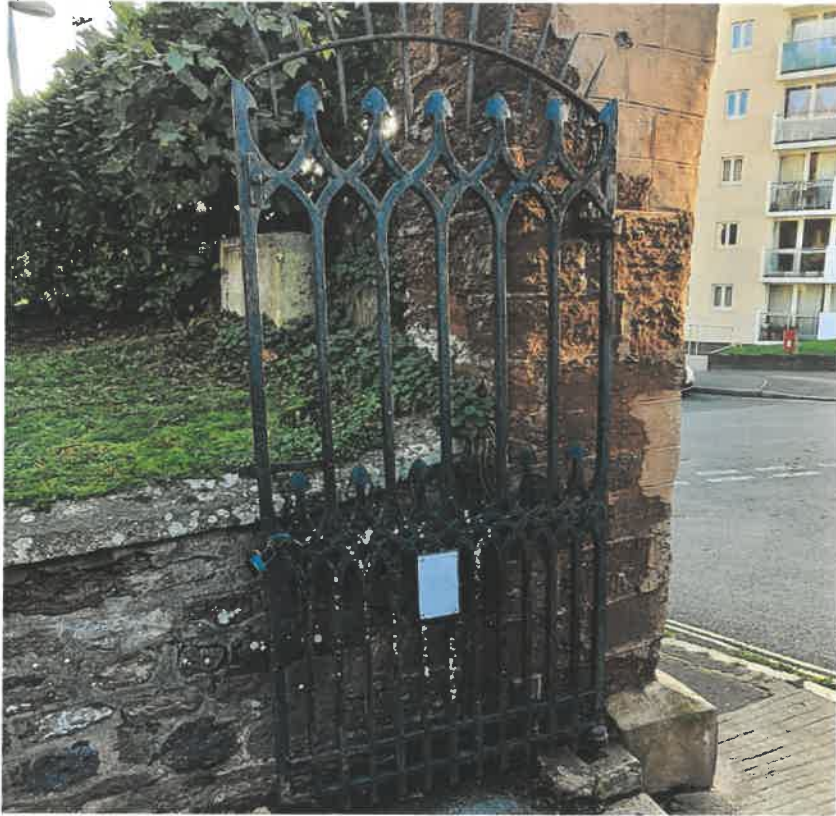
111 West Gates
